**REPORT ON THE ACCIDENT TO
MARTINAIR DC 8
PH-MBH ON 4 DECEMBER 1974**

Colombo.
16 June 1975.

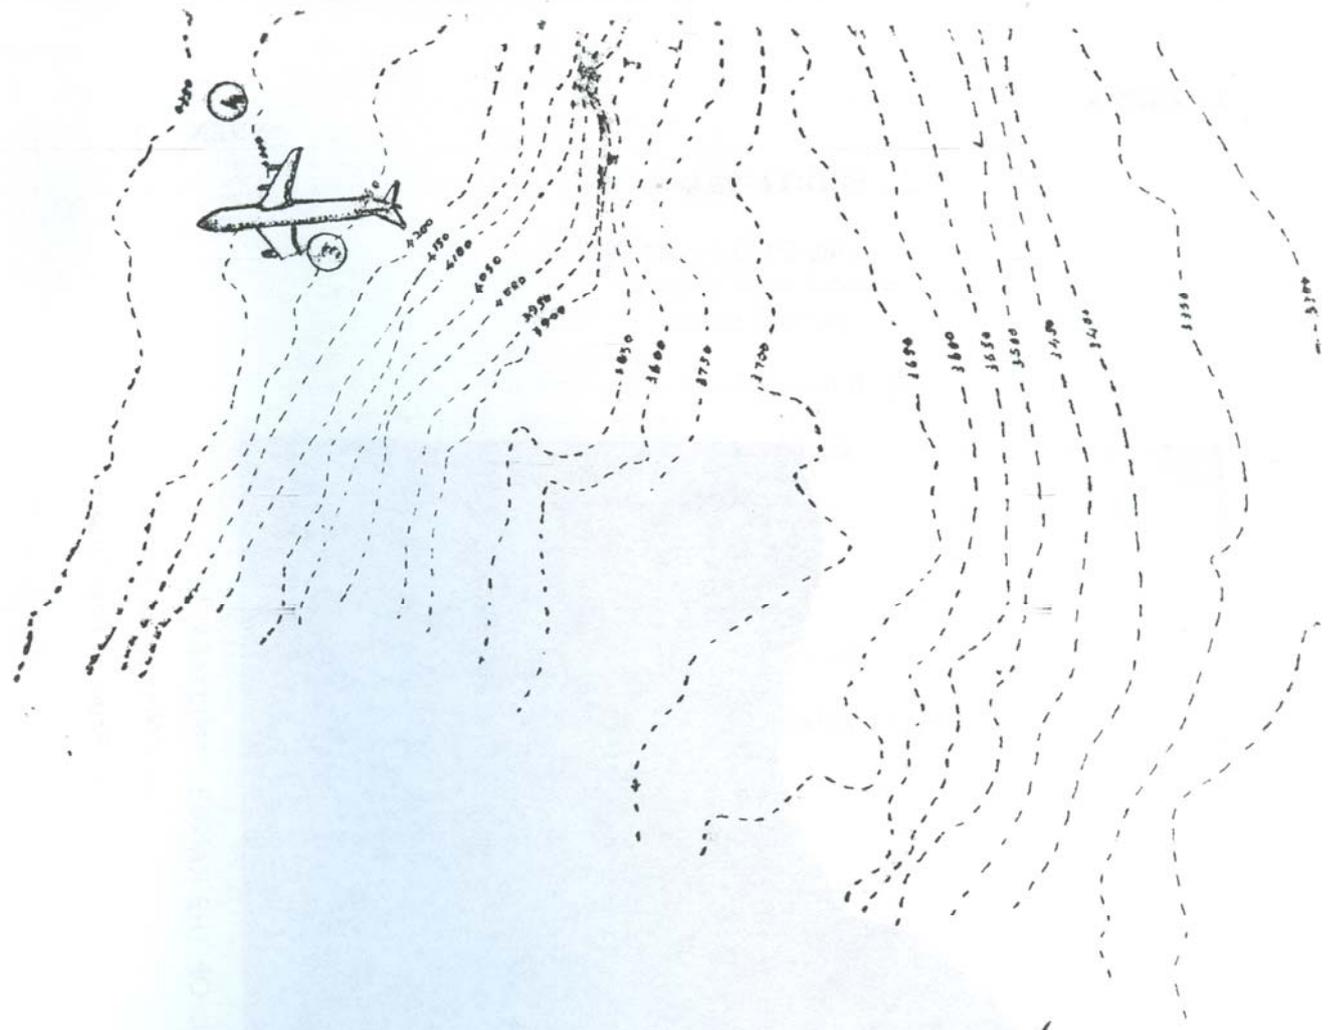
PROBABLE SEQUENCE OF FINAL IMPACT

The initial graze of the port wing on the fourth mountain and the statements of eye witnesses along the flight path indicate that the aircraft was in a descending attitude immediately prior to impact. The initial graze resulted in dislodging approximately 1/3 of the port wing which was found at the foot of the mountain.

Just before final impact on the 5th mountain the aircraft appears to have banked 30° to port, in a yaw of 15° to port and in a nose up pitch of approximately 25°. This was deduced from the damage to foliage at site of final impact. This bank and yaw were induced by the initial graze. On final impact the starboard wing had separated from the fuselage and had been thrown a distance of approximately 200 feet to the right. The ensuing fuel spillage had initiated a fire which consumed wreckage blown in that area. The initial graze and fuel spillage on the 4th mountain had brought about a fire on the 4th mountain. There was no indication of fire in the area of fuselage impact and it could be reasonably assumed that there was no fire on board the aircraft prior to impact.

- ① INITIAL GRAZE.
- ② SECONDARY GRAZE.
- ③ DEDUCED ATTITUDE OF AIRCRAFT IMMEDIATELY PRIOR TO FINAL IMPACT
- ④ SITE OF FINAL IMPACT
