## **FINAL REPORT**

**Incident of SriLankan Airlines Flight UL606, Airbus Industries A330-343, bearing registration 4R-ALR from Bandaranaike International Airport, Katunayake, Sri Lanka to Kingsford Smith International Airport, Sydney, Australia at FL390 over Indian Ocean at coordinates -7.823044,101.449898 on 21<sup>st</sup> March 2021**

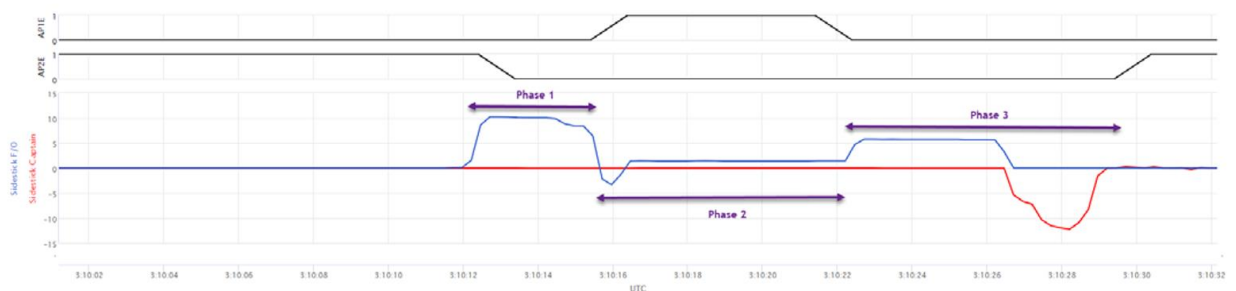
As per the analysis of DAR parameters, the incident can be elaborated in 3 main phases starting from 03:10:11 UTC;

- Phase 1 (from 03:10:11 UTC to 03:10:15 UTC): Auto Pilot 2 (AP2) disconnection
- Phase 2 (from 03:10:15 UTC to 03:10:22 UTC): Auto Pilot 1 (AP1) engagement
- Phase 3 (from 03:10:22 UTC to 03:10:30 UTC): Auto Pilot 1 disconnection
