FINAL REPORT

ATC incident between Qatar Airways Flights QTR 34U, Boeing B777- 300ER, A7-BAH and QTR 54C, Boeing B777- 300, A7-BAC within Colombo Oceanic Control Area, passing position ELATI on route N640 (westbound) on 06th May 2022

Published by: Civil Aviation Authority of Sri Lanka

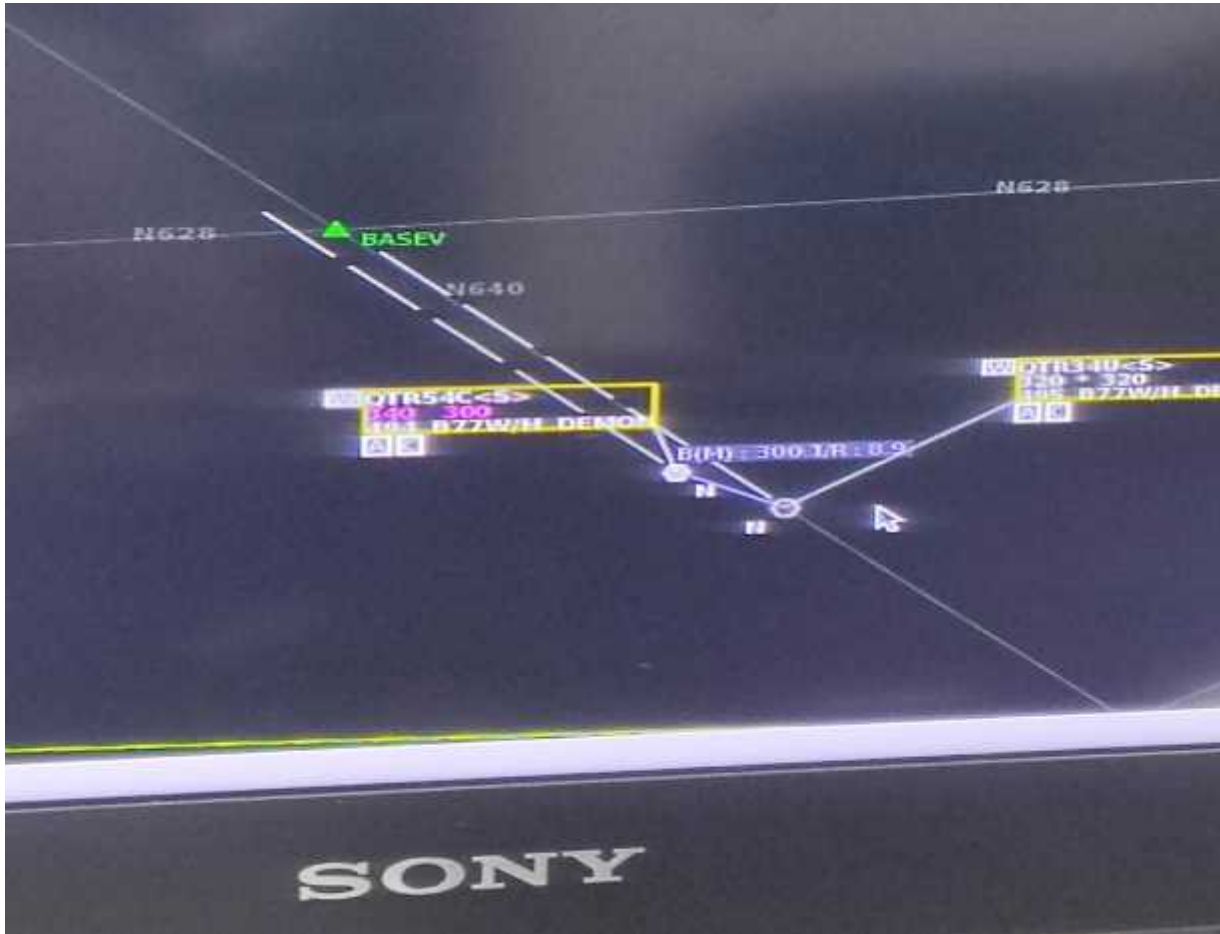
Clearance to Climb FL340, given to QTR54C, which resulted in a loss of separation. Both the Controllers failed to identify the required separation was not available for the climb to be initiated, the executive controller was unable to identify this by analyzing the strip board and had issued the approval to the CPDLC Controller to clear QTR54C for climb (as stated at the investigation interview). The ADS Controller had given the climb instructions to the aircraft without a proper analysis as a rated Controller herself, having access to the situational display where both traffic can be clearly observed as not having the required separation minima to execute such a level change.

The below Image (an excerpt of ASD recording), illustrates the breakdown of separation, where the required minima was 50Nm whereas in this instance it indicates the distance between aircraft positions was 8.9 Nm.

Figure 01: An excerpt of ASD recording which illustrates the breakdown of separation
