III වැනි සැසි වාර්තාව - 1979  
SESSIONAL PAPER No. III - 1979

Report of the Commission of Inquiry  
appointed by His Excellency the President  
to inquire into the causes and circumstances in which  
Lofleider Icelandic Airways Aircraft DC-8-63F TF-FLA  
met with an accident in the vicinity of the Katunayake Airport  
on 15th November, 1978

REPORT OF THE COMMISSION OF INQUIRY APPOINTED BY  
HIS EXCELLENCY THE PRESIDENT TO INQUIRE INTO THE CAUSES  
AND CIRCUMSTANCES IN WHICH LOFTLEIDER ICELANDIC  
AIRWAYS AIRCRAFT DC-8-63F TF-FLA MET WITH AN ACCIDENT  
IN THE VICINITY OF THE KATUNAYAKE AIRPORT ON  
15TH NOVEMBER, 1978

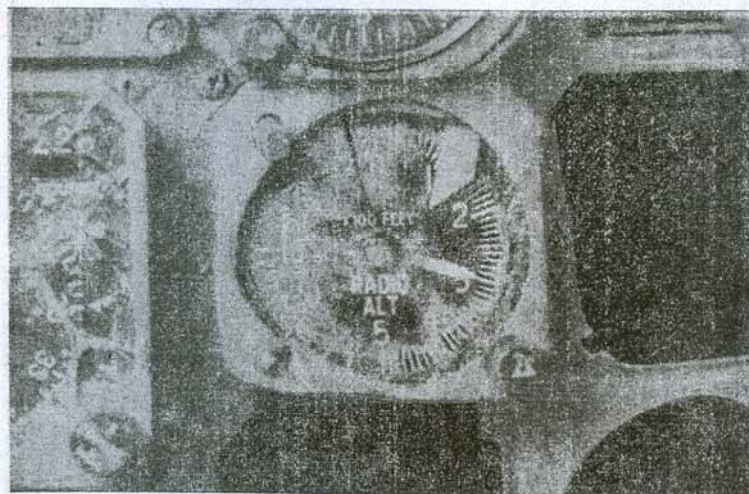
## ANNEXE X

16  
 Captain's side  
 Instruments  
 Set  
 18.1 The obstruction clearance limit (OCL) for an ILS approach to runway 22 at Katunayake is 200' (vide Annex IX). Consistent with this height was the instruction of the Captain to set the Radio Altimeter bug at 250' as seen at 23.26.45 on the transcript (Annex VII). Whilst no call-outs had been made approaching the MDH, the Radio Altimeter (RA) found on the Captain's panel of instruments recovered from the wreckage showed the bug set at 150' —vide the photograph, Annex X. It is not possible to determine at what stage the bug on the RA had been set to 150'.

18.4. On the other hand, if the Captain had correctly set his radio altimeter bug at 250', the warning light would have come on when the aircraft came down to that height. If he was scanning his instruments, he could not have failed to notice that fact. In that event, one cannot understand why he did not overshoot if the runway was not within view.

## PHOTOGRAPH OF THE RADIO ALTIMETER

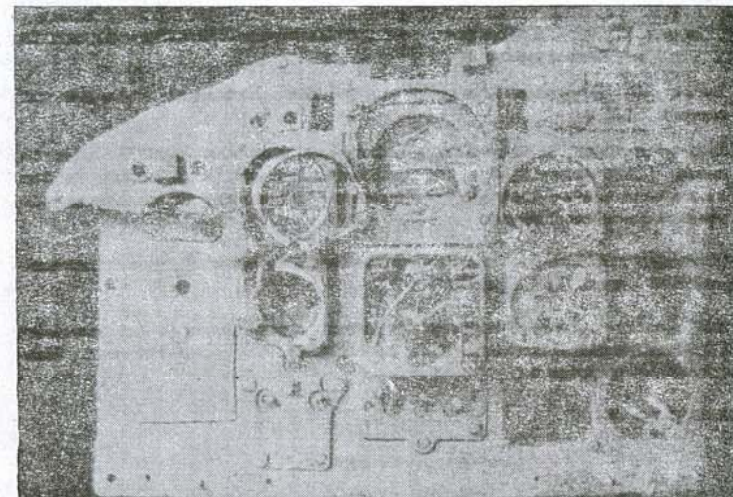
## ANNEXE XIV

22.10. The glass of the Course Indicator was only partly broken but there were small pebbles and mud under the glass. The Glide Slope Pointer was not embedded but was movable. In these circumstances, it is not possible to state with any reasonable degree of certainty that the position of the Glide Slope Pointer as shown in the photograph (Annex XIV) was the self-same position at the time of the crash. The position may well have altered as a result of the force of the impact and, in considering the evidence, therefore, much importance cannot be attached to the fact that the photograph shows the indicator to be only about half a dot above.

PHOTOGRAPH OF THE PILOTS INSTRUMENT PANEL RECOVERED  
FROM THE WRECKAGE
