FINAL REPORT

SRI LANKAN AIRLINES AIRBUS A330-300, 4R-ALQ COCKPIT & CABIN SMOKE INCIDENT DURING CLIMB FROM MEL TO CMB AT FL 220, 60NM NORTH-WEST OF MEL AIRPORT ON 12TH FEB 2024

Released by the Civil Aviation Authority of Sri Lanka

Issued on: 18/09/2024

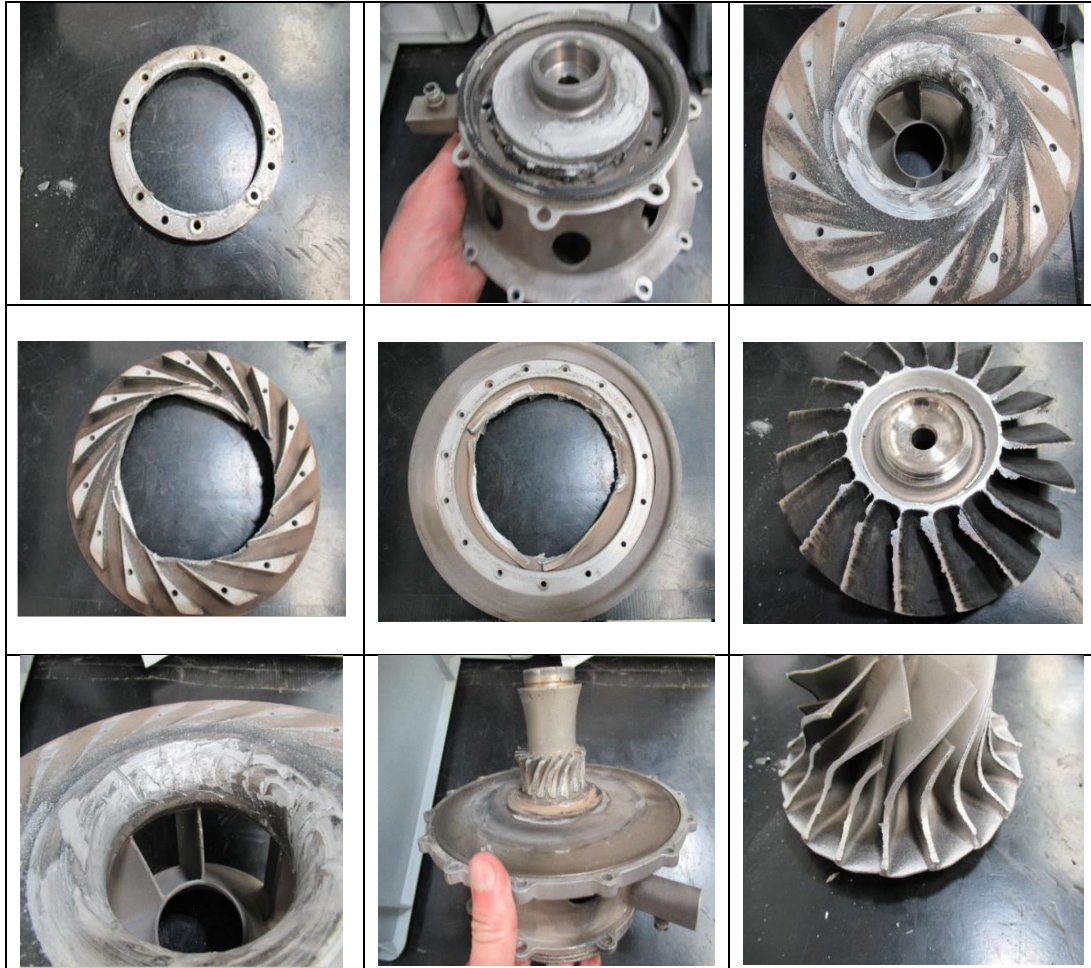
Figure 02: Pictures of Damaged parts of the ACM

3.1.5. At the post flight troubleshooting and inspections as per applicable TSM it had been observed that Pack 1 - ACM had seized and metal particles were inside the ducts.

- 3.1.6. Affected ACM was found with rotating assembly has been seized with excessive internal damage.
- 3.1.7. There were no MPD tasks related to the ACM.
- 3.1.8. The ACM had been installed at the time of delivery of the aircraft from the manufacturer Airbus in December 2015. No inspection, cleaning, or removals had been performed until the occurrence of the incident since there were no MPD tasks related to the component.
- 3.1.9. The Pack-related MPD tasks
- MPD 215354-01: Cleaning and detailed inspection for the erosion of Pack water injector had performed on 2 nd November 2023.
 - MPD 215200-24-1: Discard of flexible hose (each 18000FH) from air cycle machine between compressor and turbine had performed on 10th September 2023
- 3.1.10. The ACM manufacturer evaluation reports that the component failure cannot be detected due to the level of disintegrations of the unit.

- 3.2.1. Seizure of the ACM was the most probable cause of this incident.
- 3.2.2. But the ACM manufacturer's evaluation reports that the component failure cannot be detected due to the level of disintegration of the unit.

- 4.1. A task against the ACM has to be introduced to the operator's reliability programme.
- 4.2. A customized soft time interval for inspection, cleaning and overhaul of the ACM shall be introduced by the operator with their reliability figures.

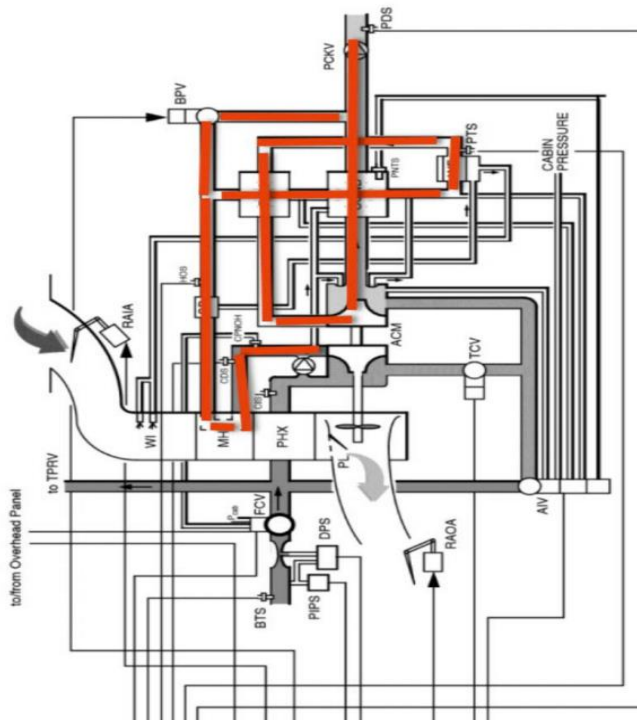
Figure 03: Air conditioning System diagram with ACM location

The circumstances leading to the incident was the failure of the Air Cycle Machine (ACM) of the pack no.1 of the aircraft air conditioning system.
