FINAL REPORT

**SriLankan Airlines Flight UL 226,
Airbus Industries A330-200, bearing registration 4R-ALS,
experienced a lateral runway excursion during
landing at Bandaranaike International Airport, Katunayake,
Sri Lanka on 08th July 2024**

Released by the Civil Aviation Authority of Sri Lanka

Issued on: 5th Feb 2025

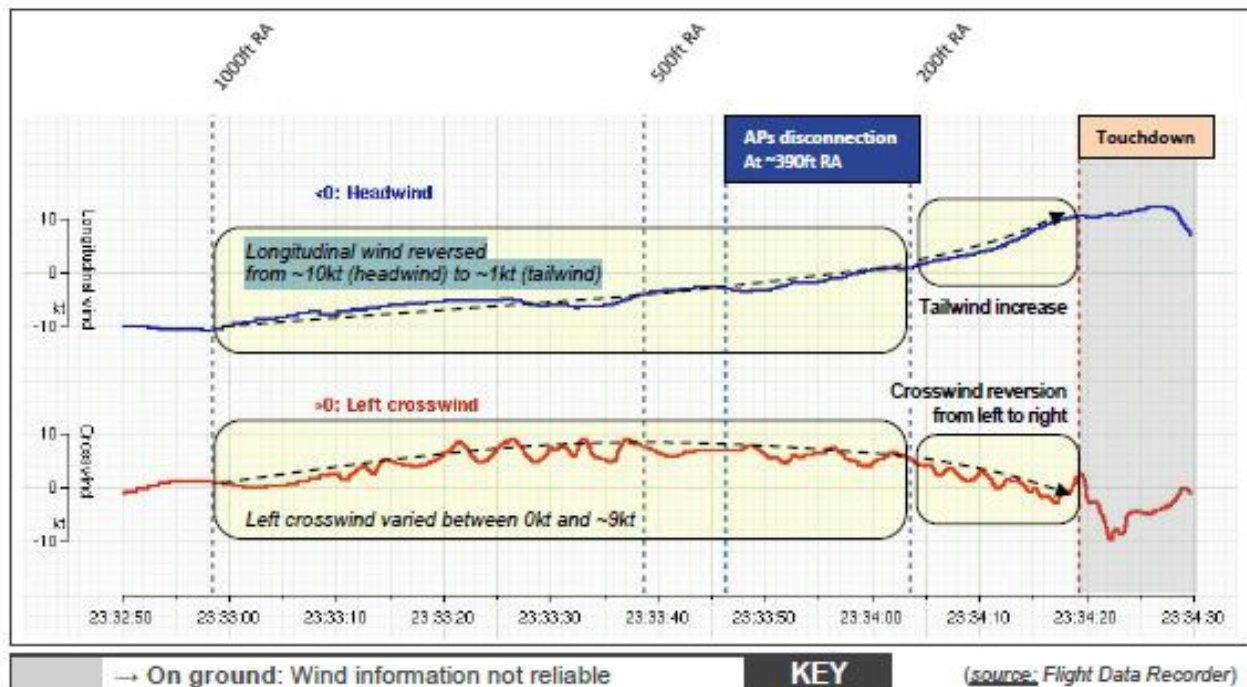
Figure 1 – Reconstructed wind along the runway axes (Source: Flight Data Recorder)

From approximately 150ft RA (23:34:08 UTC) to touchdown (23:34:20 UTC), PF applied several left and right roll orders, with a left roll tendency, leading the roll angle to increase up to a maximum of -3.5° (left roll) and the roll angle was thus mainly a left roll in the last 10s before touchdown (Shown as ③ in Figure 2). At the same time, according to the wind analysis, the crosswind component started to reverse from left to right (In the last 200ft, the crosswind component reversed from approximately 5kt left to 3kt right – Refer Figure 1).

The mainly left roll angle maintained for approximately 10 seconds, associated with the crosswind reversion, initiated a left dynamics leading localizer deviation to start increasing and therefore, the aircraft deviated to the left of the runway centreline.

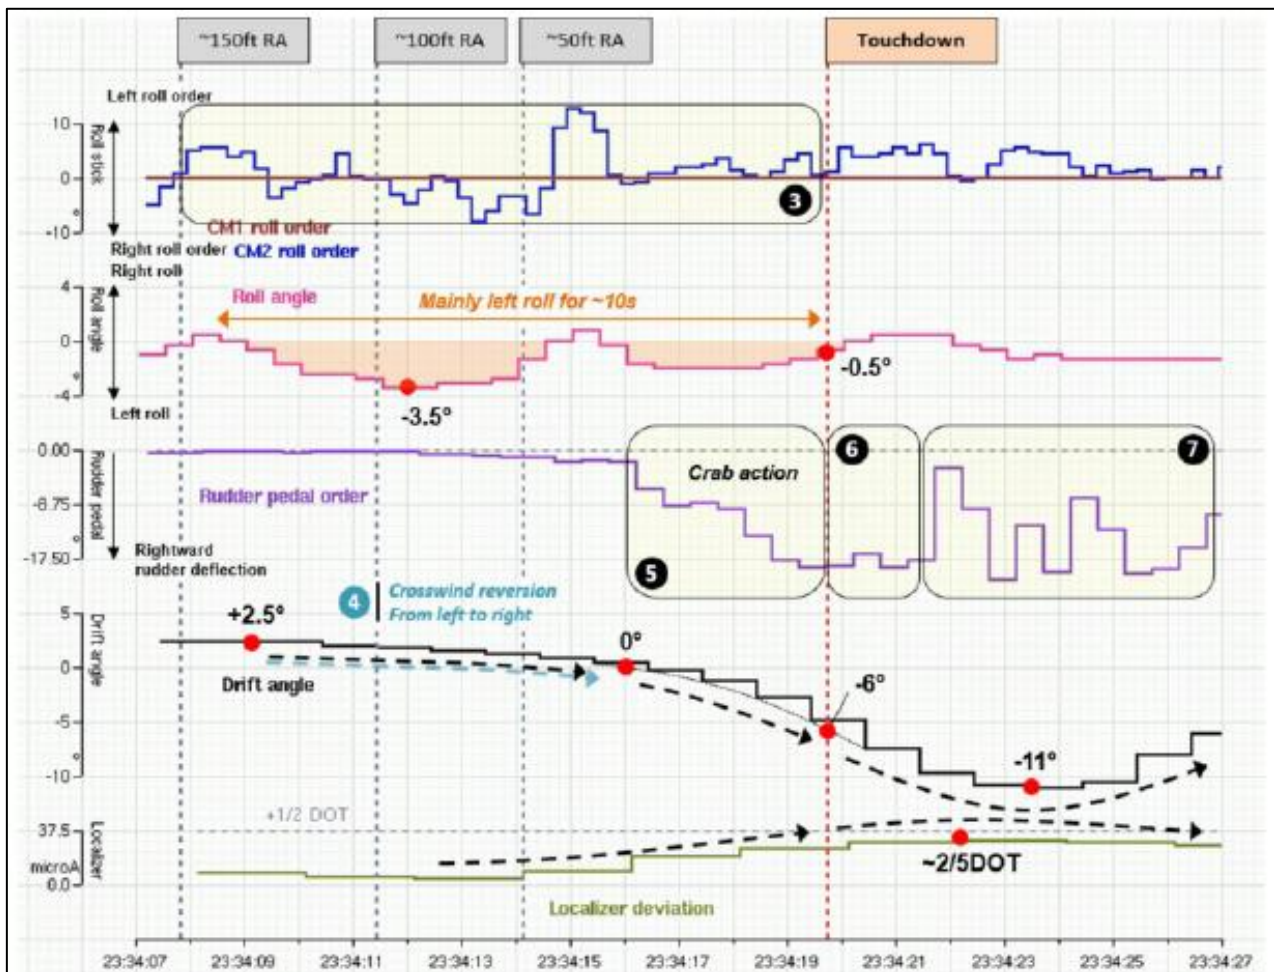
Figure 2 - The last 150ft / Lateral and directional axes (Source: Flight Data Recorder)

Approximately from 20ft RA, most probably to counter the left deviation, the flight crew applied a rightward pedal order up to half of full deflection (Shown as 5 in Figure 2). This rightward rudder pedal order (crab action), associated with the crosswind reversion, led the drift angle to increase up to -6° (aircraft nose toward the right of the track) prior to touchdown. The aircraft touched down at approximately 250m after the runway threshold with a localizer deviation around $+2/5\text{DOT}$ to the left of the runway.

After touchdown, the rightward rudder pedal order applied just before touchdown was maintained (Shown as 6 in Figure 2). Consequently, the drift angle continued to increase up to -11° .

Then the rightward rudder pedal order (Shown as ⑦ in Figure 2) was almost fully released by the flight crew before being reapplied up to approximately $3/5$ of full right deflection and as a result the lateral deviation reduced. Around 23:34:26 UTC, the runway was recovered (all main landing gears were on the runway) around 700m after threshold. Then, the runway centreline was recovered around 900m after threshold and the aircraft then exited the runway via taxiway C and taxi was performed uneventfully.

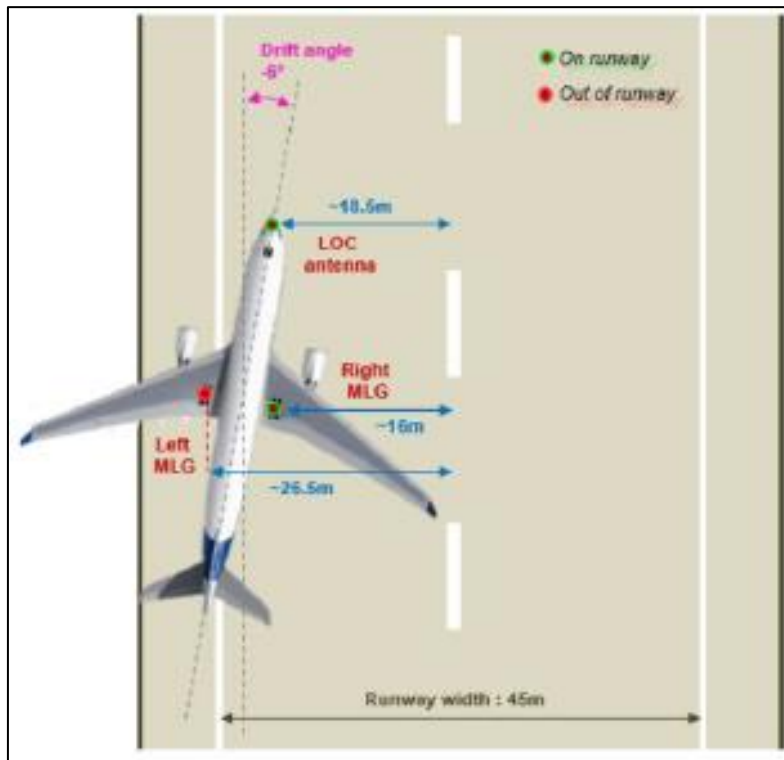
Figure 3 – Initial touchdown analysis (Source: Flight Data Recorder)

The aircraft thus touched down with the left MLG on the runway shoulder (out of runway) and with the right MLG still on the runway. At that time, left MLG position was around 26.5m on the left of the runway centreline and the right MLG position was around 16m on the left of the runway centreline (runway width of 45m and the side stripe marking was at 22.5m from centreline).

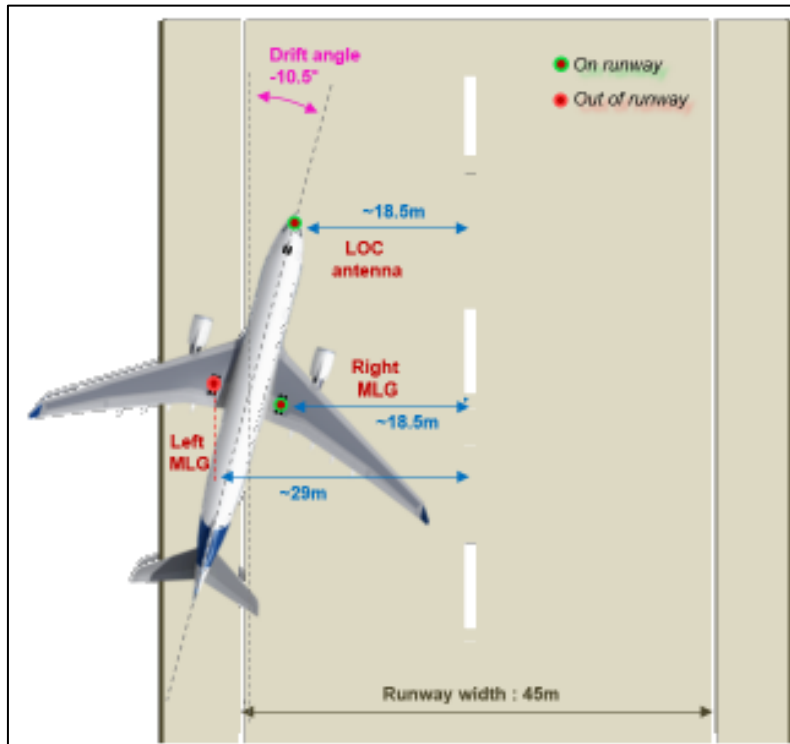
Figure 5 – After touchdown analysis (Source: Flight Data Recorder)

Concomitantly, the localizer deviation reached its maximum of around $+2/5$ DOT to the left of the localizer before starting to decrease. During this period the aircraft veered further to left resulting left MLG moved further left up to around 29m and the right MLG positioned up to around 18.5m on the left of the runway centreline. At that time, based on estimated trajectory, the left MLG was out of the runway (still on the paved surface) and the right MLG was on the runway.

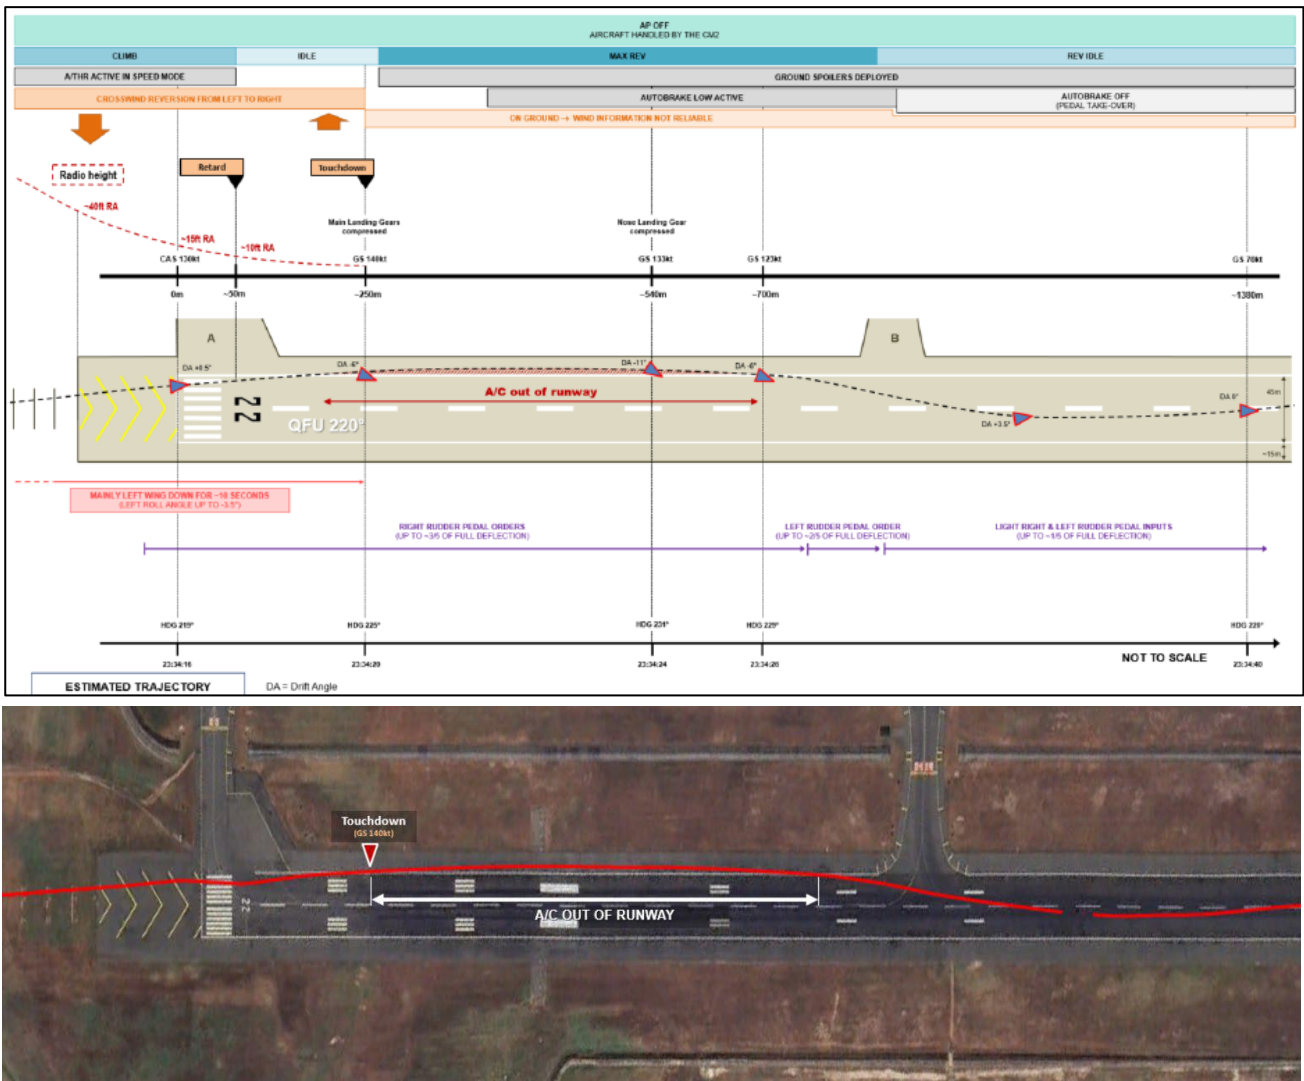
Figure 6 - An estimated aircraft trajectory (Source: Flight Data Recorder)

As mentioned in Section 1.1, the PF had tried to land without success to prevent the aircraft from continuing to drift towards the left edge of the runway. The aircraft touched down at approximately 250m after the runway threshold with the left main landing gear on the runway shoulder (out of runway) and with the right main landing gear still on the runway. The runway was recovered (all main landing gears were on the runway) around 700m after threshold and the runway centreline was recovered around 900m after threshold (Shown in Figure 6).

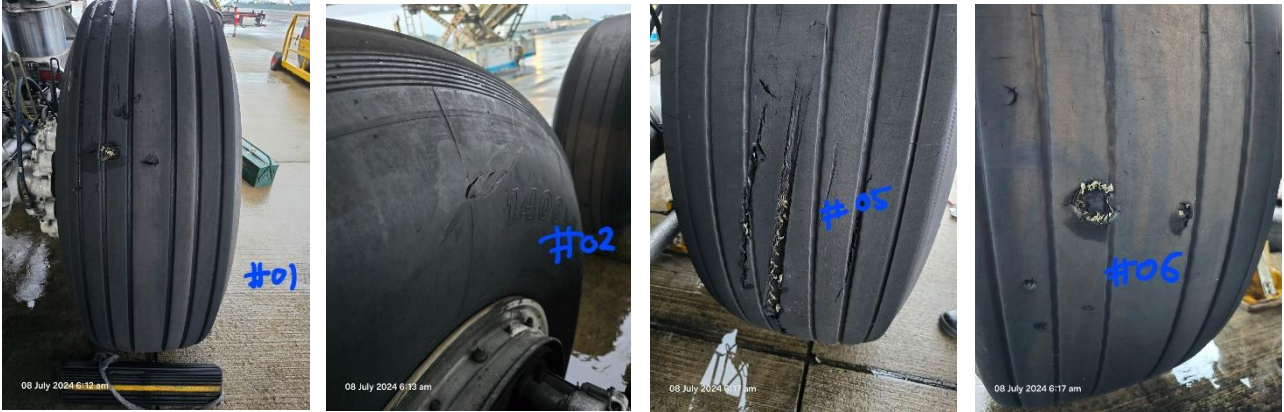
Figure 7 – Damages to the tyres of left MLG

During post flight inspection a maintenance technician observed that all four tyres on left MLG were damaged and he informed situation to duty engineer, but there was no pilot report regarding the incident. After the engineer's inspection, he informed Apron Control supervisor regarding the incident through Flight Control Centre.

All 4 tires (# 1,2,5 & 6) of the left main landing gear were damaged.

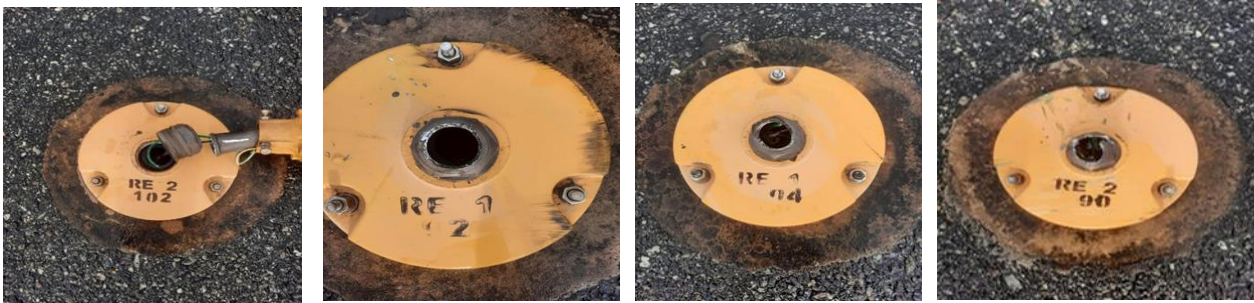
Figure 8 – Damaged runway edge lights

Four (04) Runway edge lights were damaged.

During the subsequent inspection approximately at time 0555 Local, they found that four runway edge lights on left side of runway 22 were damaged and some tyre derbies were on the edge of the runway 22 landing zone. The transmission of inaccurate information from the source (SriLankan Engineering Department), about the tyre damage, caused the inspection team to focus on a potential tyre burst, leading them to overlook Foreign Object Debris (FOD) during the initial inspection.

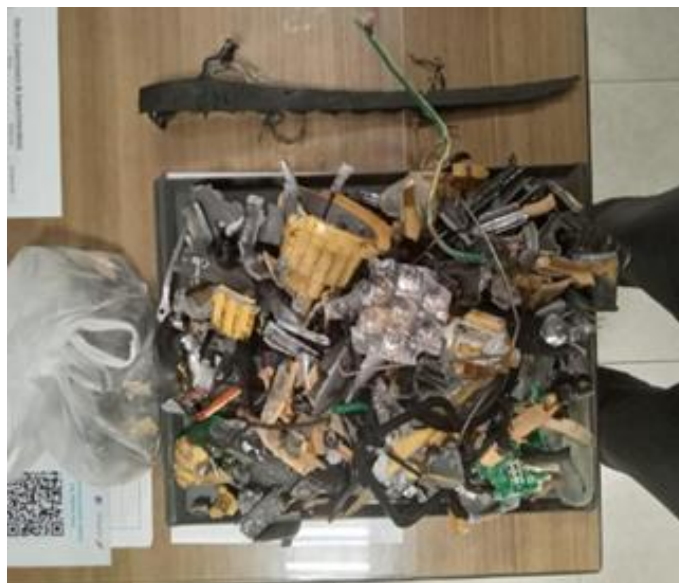
Figure 9 – Runway edge light and tyre debris recovered from runway

Therefore, the damaged runway edge lights and tyre derbies posed a FOD hazard other aircraft used the runway 22 until it was detected.

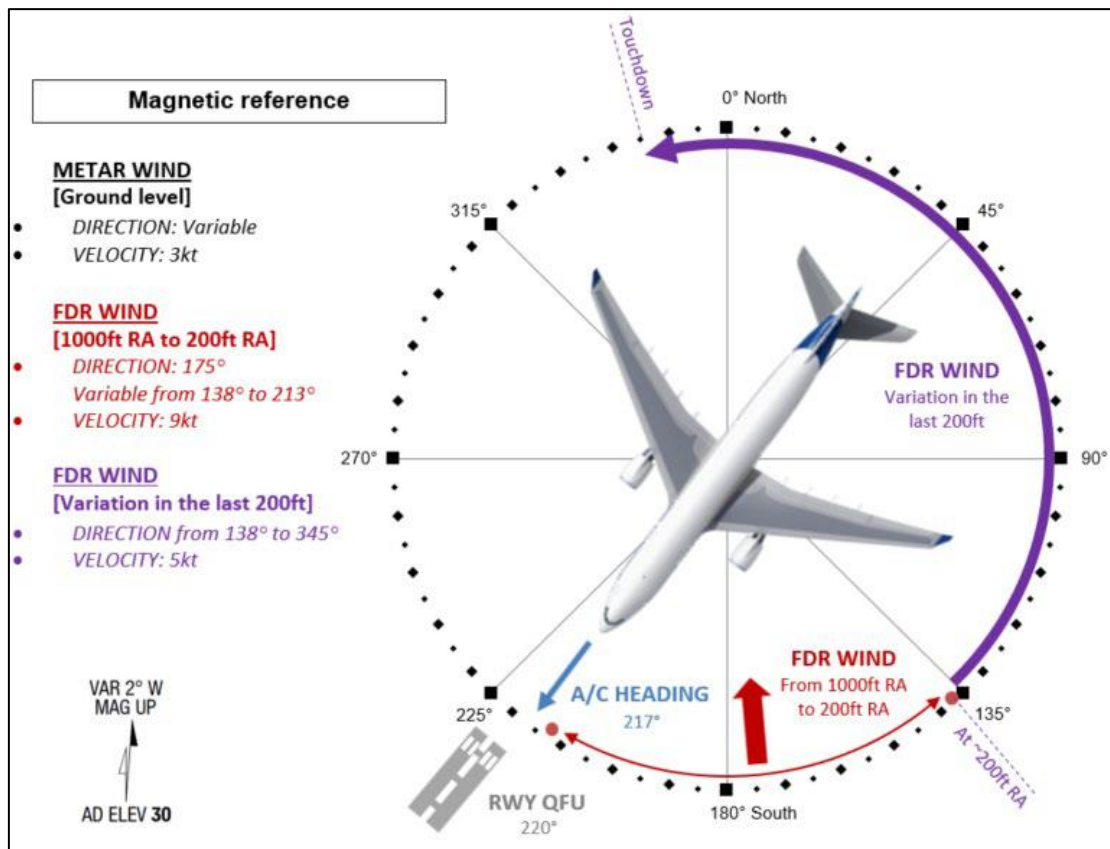
Figure 13 - Wind conditions sum-up (Source: Flight Data Recorder)

According to the flight crew, they were not affected by the prevailed light rainy condition and however, associated with the crosswind reversion from left to right, left roll input applied by PF, initiated a left roll dynamics and lead to an increased localizer deviation to left (The aircraft deviated to the left of the runway centreline).
