FINAL REPORT

Incident of Loss of Standard Minimum Separation between ALK122 and FDB1026 at Bandaranaike International Airport, Katunayake, Sri Lanka on the 9th of January 2024

Released by the Civil Aviation Authority of Sri Lanka

Issued on: 20 Feb 2025

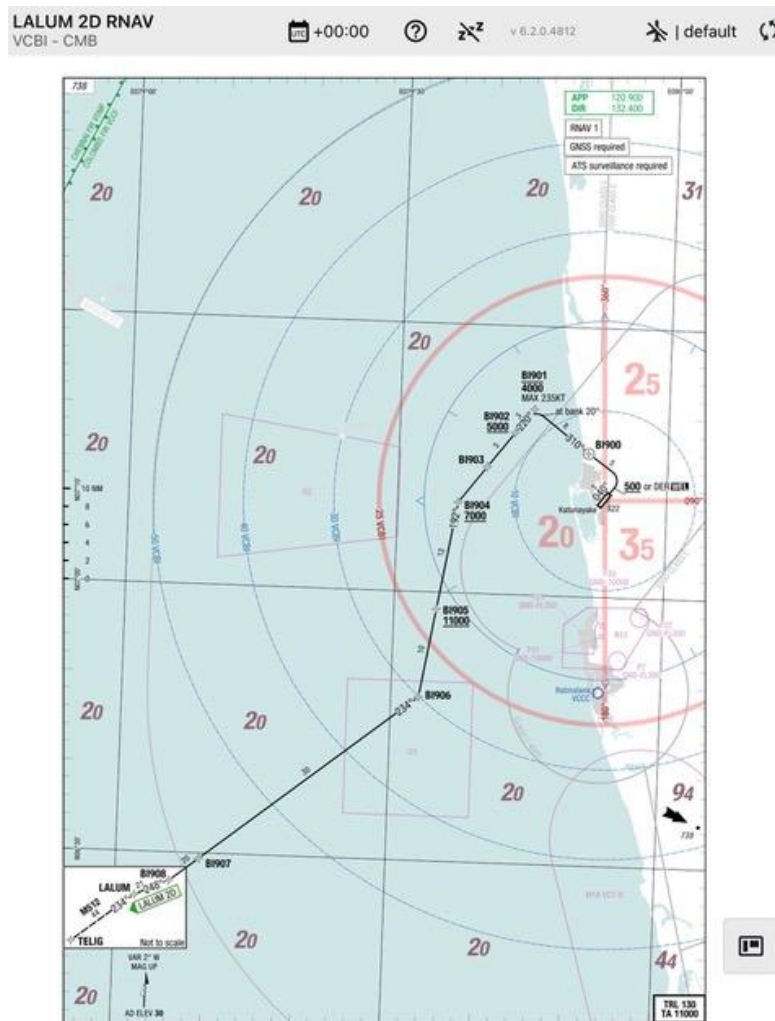
Figure 01 : Standard Instrument Departure Runway 04 of VCBI

2. The flight FDB1026 has been issued with clear instructions to follow the Standard Instrument Departure Procedure SID/LALUM2D for Runway 04 at two instances. Once at the time of issuing the ATC clearance prior to start up and secondly, at time 05:54.22(UTC), when the aircraft was identified by the Approach Surveillance Controller for the provision of ATC services. Instructions issued was to Climb to Flight Level 240 via the SID which the PIC of FDB1026 read back at time 05:55.24(UTC). The phrase “Climb via SID” as published, denotes that the Pilot shall comply with published level restrictions, speed restrictions applicable to SID while complying with lateral profile of the SID. Pilot had complied with the lateral profile of the SID but had failed to comply with the vertical restrictions associated with the SID. In the process FDB1026 has climbed above 4000ft prior to waypoint BI901 violating the restriction imposed to remain at or below 4000ft passing way point BI901.

3. PIC of FDB1026 while complying the lateral profile of the the SID/LALUM2D has failed to comply with published vertical profile, ie. level restrictions, speed restrictions applicable.
