FINAL REPORT

Incident involving a hard landing of the Cessna 152 aircraft operated by Asian Aviation Center, bearing registration 4R-ACV, at Colombo International Airport, Ratmalana, Sri Lanka on 08th June 2024.

Released by the Civil Aviation Authority of Sri Lanka

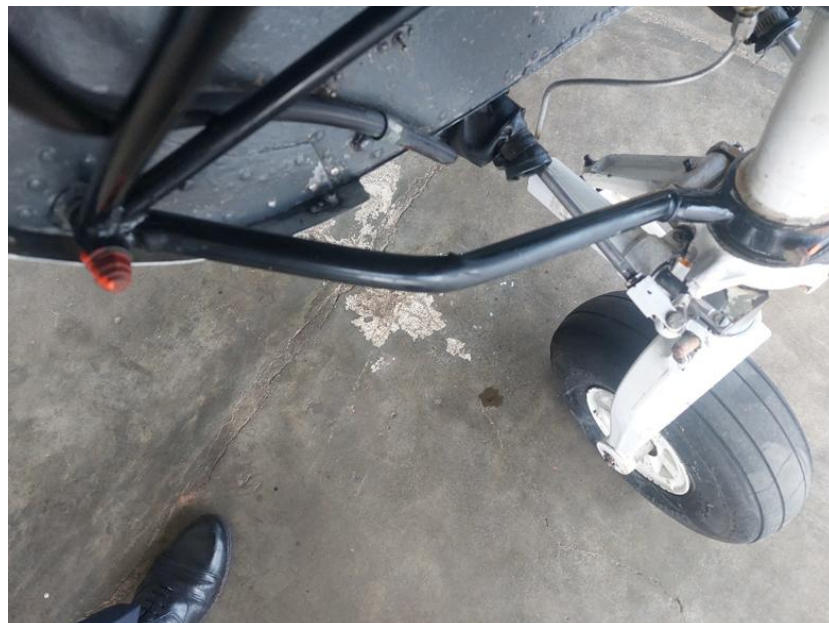
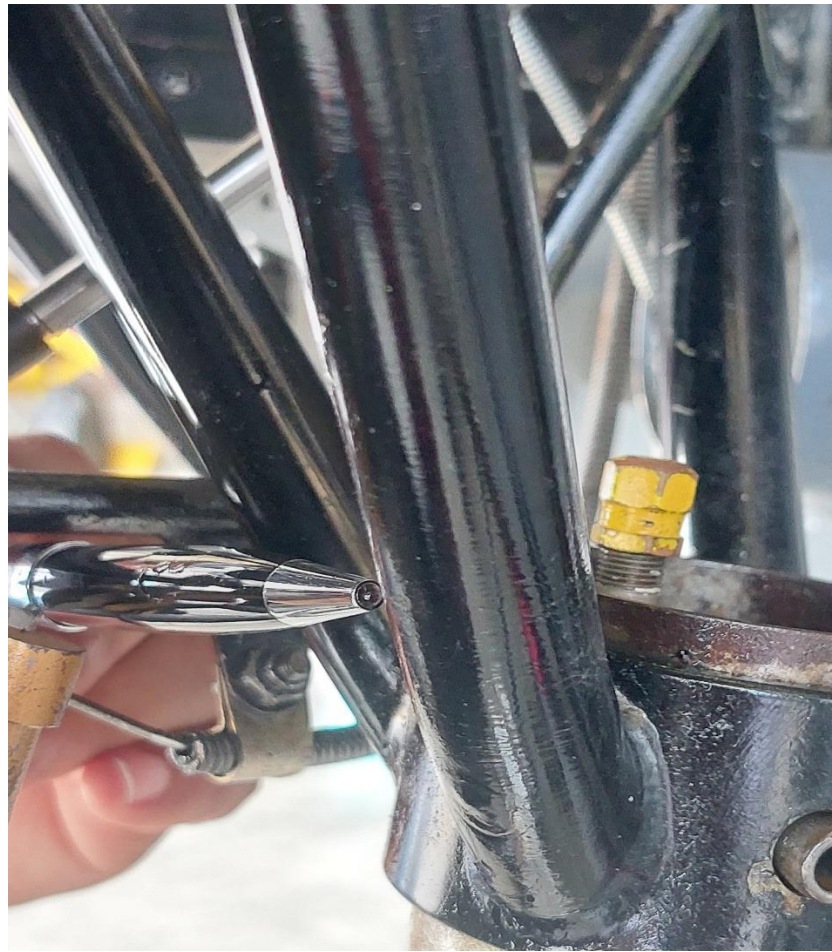
Figure 01: Damages sustained to the Engine mount

2.3.1 Engine Mount Frame.

The tubular bar on the left side of the lower engine mount was bent in the middle. This bend resulted from a compression force exerted due to the landing gear being forced to the right (when viewed from the cockpit).

- 3.3.2** During the initial exterior inspection, the team members observed the damage listed in Para 2.3. Upon analyzing the damages, it was evident that the aircraft had landed hard on the nose wheel with right rudder applied (right pedal forward), resulting in damage to the engine mounts and right nose wheel steering tube attachments. In addition to the visible damages listed above, it was found that there was no air pressure in the olio pneumatic nose wheel strut. Further investigation revealed that the engine mounting bolt holes had been enlarged due to the impact, and the mounting bolts were severely stressed.

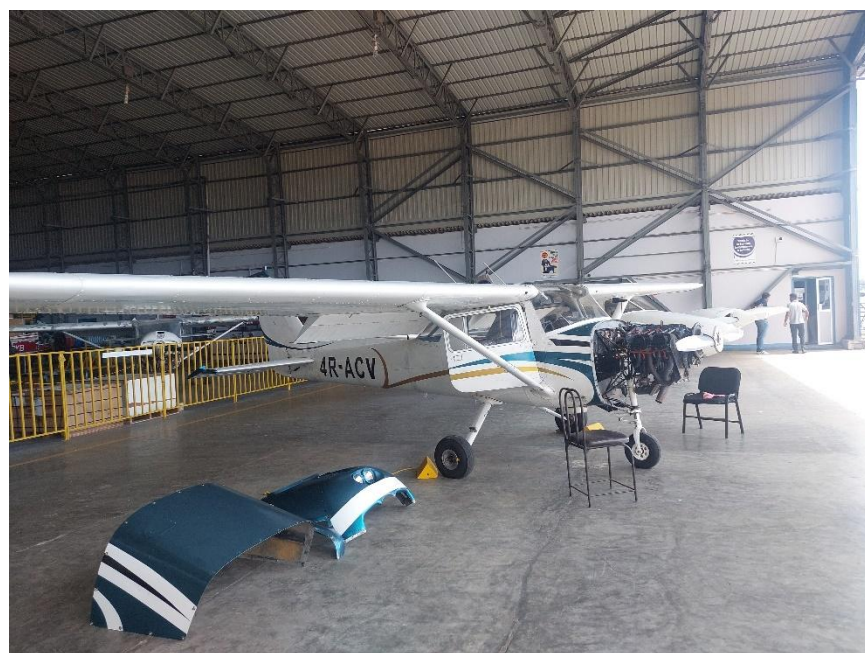
Figure 03: The effected Nose Landing Gear (bent backwards)

2.3.2 Nose Landing Gear Oleo Strut

The nose landing gear was abnormally bent backward, which was a result of the deformation in the tubular engine mount.

- 3.3.3** There was no evidence of any prior defects or malfunctions in the aircraft flight control systems or engine that could have contributed to the incident. However, the absence of the proper oil-to-air ratio in the NLG olio strut before the flight caused the strut to perform poorly, resulting in adverse consequences to the airframe and the rudder control linkage.

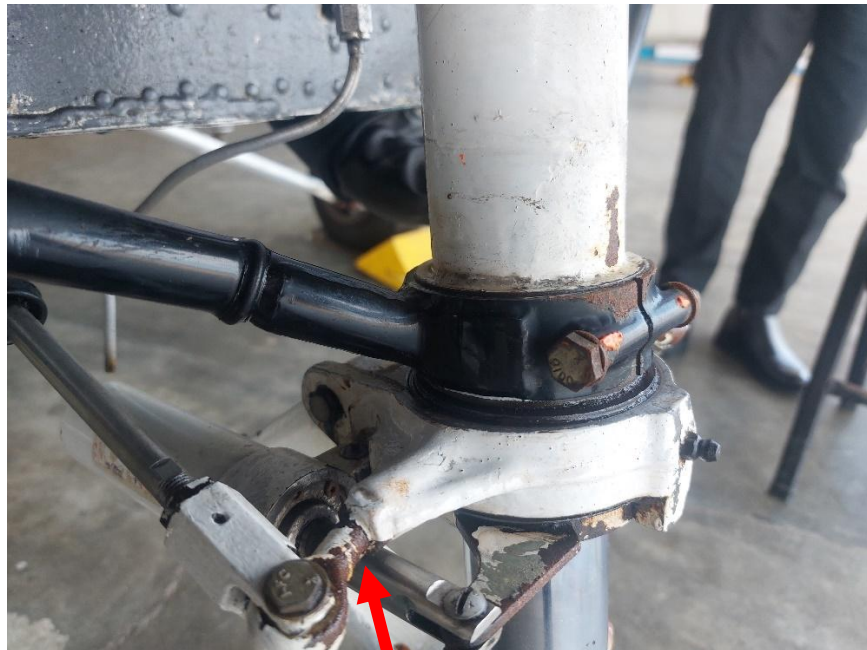
Figure 04: Distorted Torque Link

2.3.3 The Right-Side Torque Links and Attachments

This is the right-side torque link attachment of the steering system. The right-side torque link attachment of the nose steering system was found to be damaged following the incident.

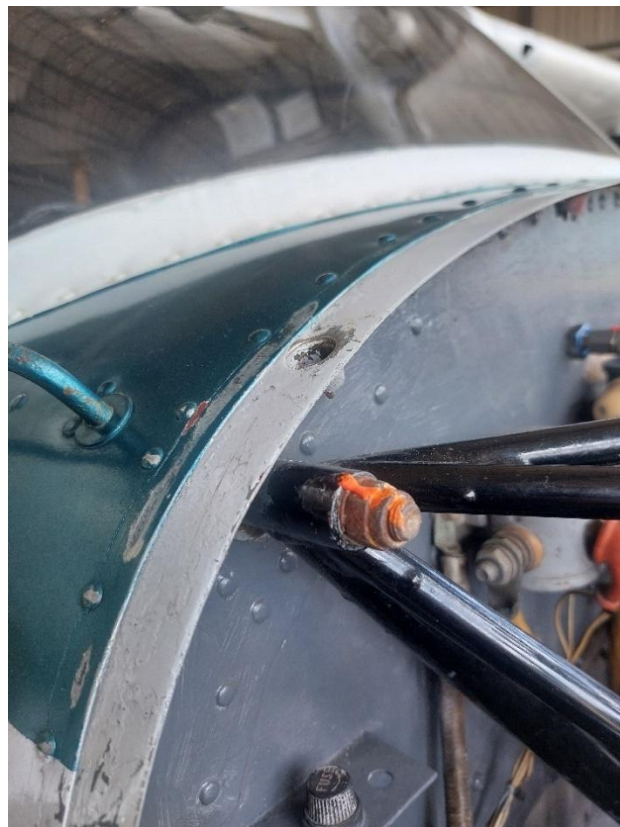
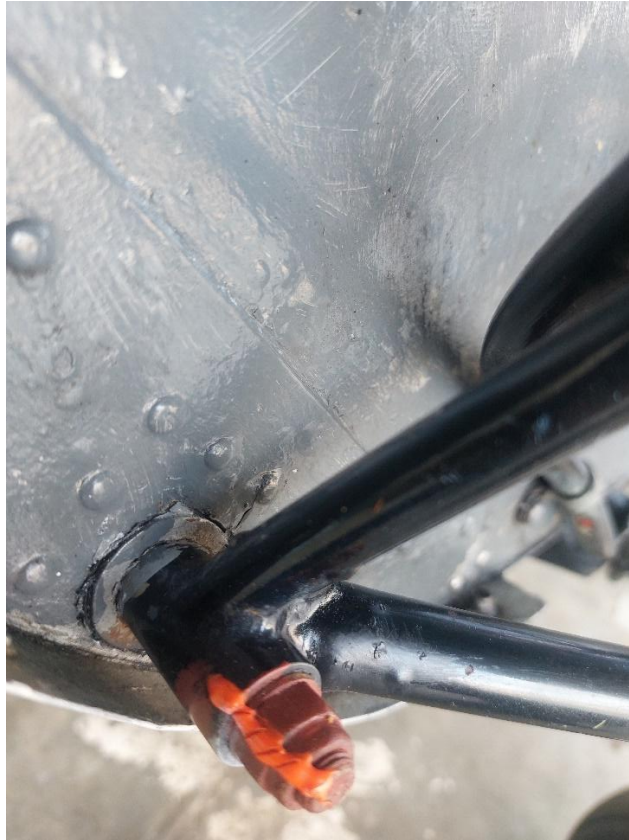
Figure 05: Right upper Engine Mount

2.3.4 All Four Engine Mount Attachments on The Firewall

Upon inspection, it was found that the bolt holes of the bulkhead were enlarged, and the bolts themselves were affected due to the excessive forces applied during the incident.

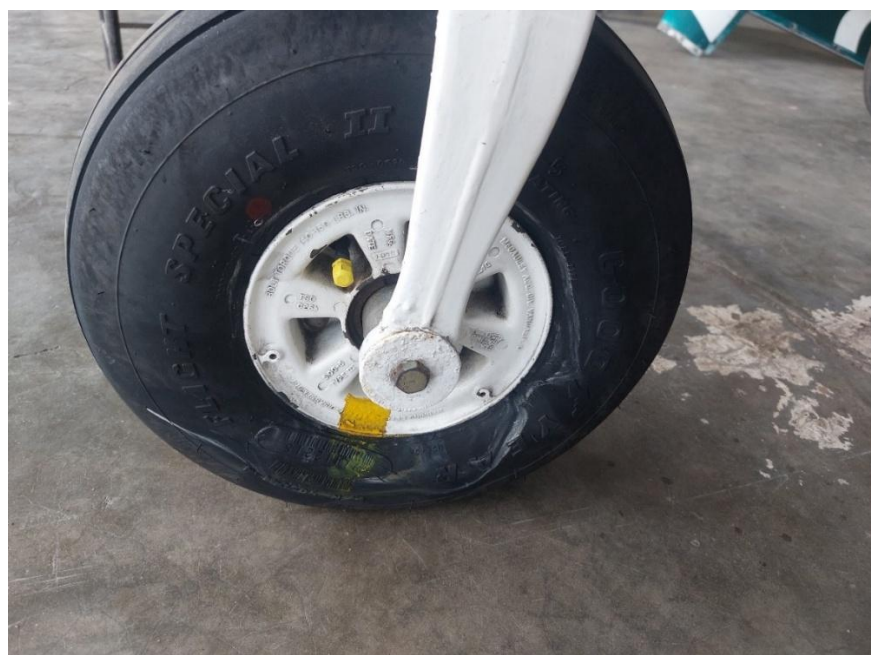
Figure 07: Impact Marks NLG

2.3.5 Damage to Nose Wheel Assembly

The white marks observed on the tire indicate that the left side wall of the tire had contacted the ground due to leftward force landing. The impact caused the tire to compress significantly, leading to the rim making contact with the ground. This impact has resulted in the removal of yellow color creep marks that existed prior to the flight. Therefore, the nose wheel assembly have experienced abnormal forces.

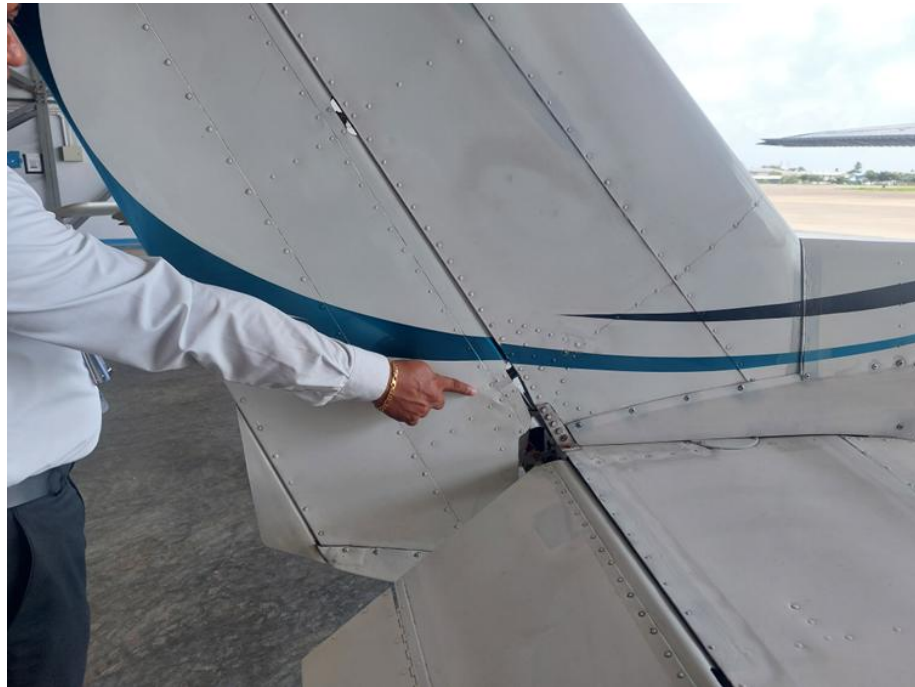
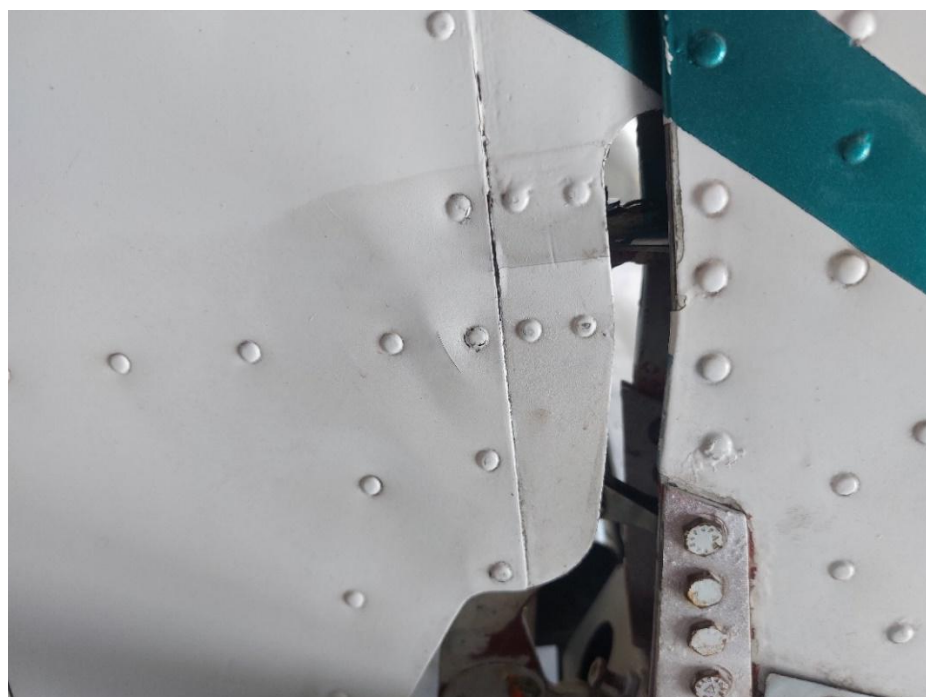
Figure 08: Wrinkles at the Rudder mounting Area

2.3.6 Rudder Functional Test - Unsatisfactory Result

The rudder functional test was not satisfactory, as the rudder pedals did not operate freely. This issue arose due to the excessive force applied to the steering linkage, which resulted in the lower rudder mounting bracket making contact with the aircraft's skin. This contact caused wrinkles in the skin, restricting the movement of the rudder. As a result, the rudder did not move as expected during the test.
