FINAL REPORT

Separation Minima Infringement Incident Involving AirAsia Flight AXM 46, SriLankan Airlines Flights ALK 607 and ALK 104, bearing aircraft registrations 9M-AJG, 4R-ALR, and 4R-EXR respectively, on 19th September 2023 at Bandaranaike International Airport, Katunayake, Sri Lanka.

Released by the Civil Aviation Authority of Sri Lanka

Issued on: 21st March 2025

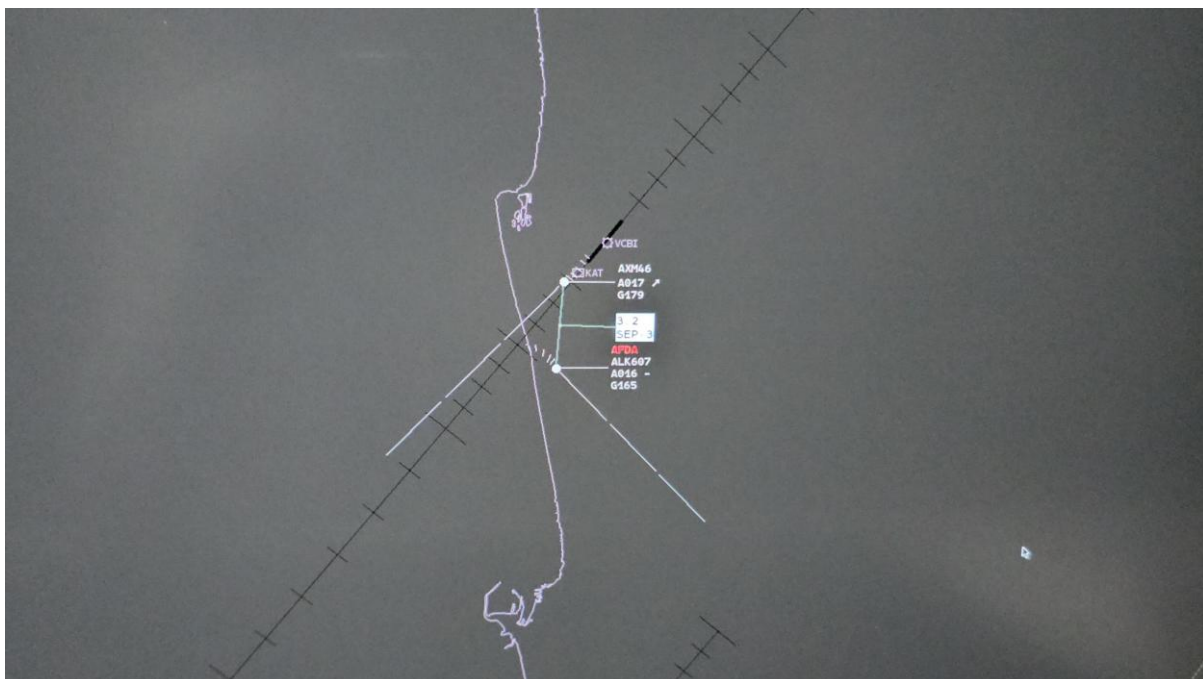
Meanwhile, AXM46 had been cleared for take-off ahead of ALK 607 by the Tower Controller. While AXM46 was rolling on RWY 22, ALK607 had established at 6NM on final approach on RWY 04. At that moment both aircraft ALK607 and AXM46 were

on reciprocal Tracks arrival was on unrestricted descend to land and the departure was on unrestricted climb respectively.

Figure 01: Standard minimum separation break down between AXM46 and ALK607

- (a) The Approach Controller has positioned ALK607 for landing on RWY04 and AXM46 for departing from RWY22 resulting in both aircraft being positioned for an unrestricted collision course for a moment of time. When the provision of a solution to the issue Approach Controller has failed to maintain the minimum required separation standard between aircraft in surveillance environment. This constituted non-compliance with Section 6.3 of the Unit Operation instruction of Colombo Approach Control Centre of SLMATS has led to an infringement of standard minimum separation between ALK 607 and AXM46.

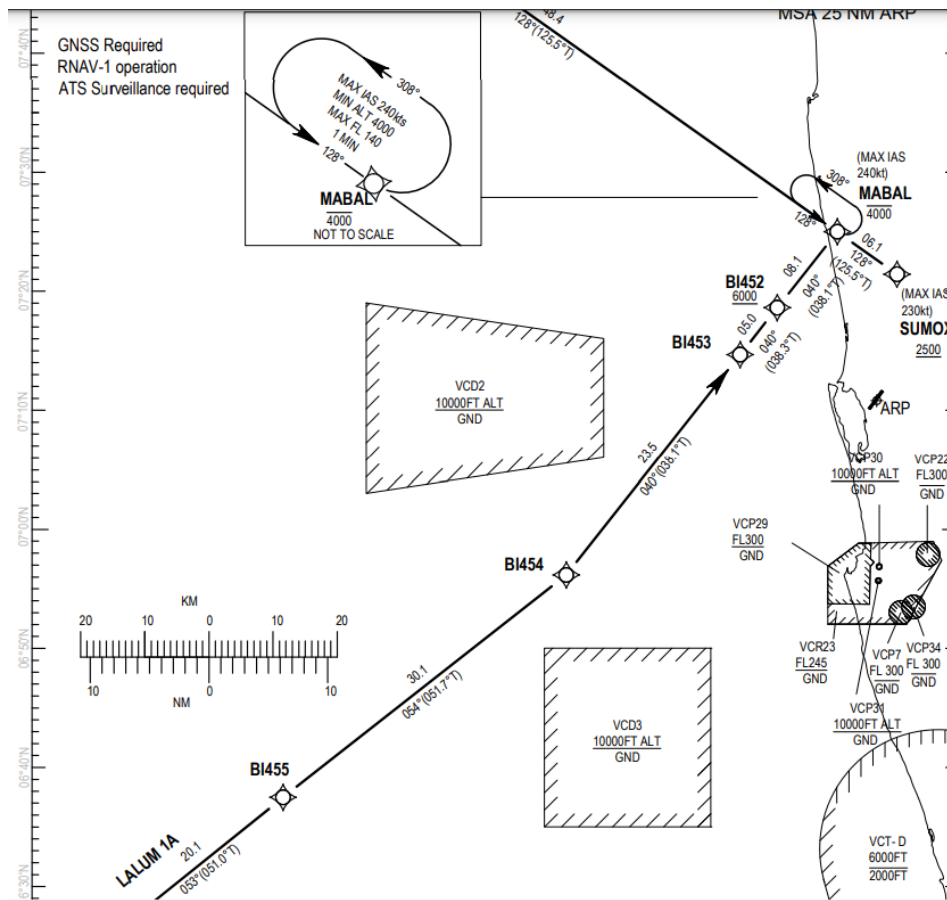
- ALK 607 had deviated far towards WEST of her inbound track and been tracking Southwest of Colombo City Restricted area at the time of handing over from the Area Control Centre to the Approach Control Centre VCBI.
- ALK104 also had experienced weather enroute and communicated the same to the Approach Controller specifically mentioning her inability to extend the downwind leg if deemed necessary for delay purposes beyond position MABAL as there was weather build up.

Figure 2, Arrival star from Male (LALUM 1A) and Position MABAL

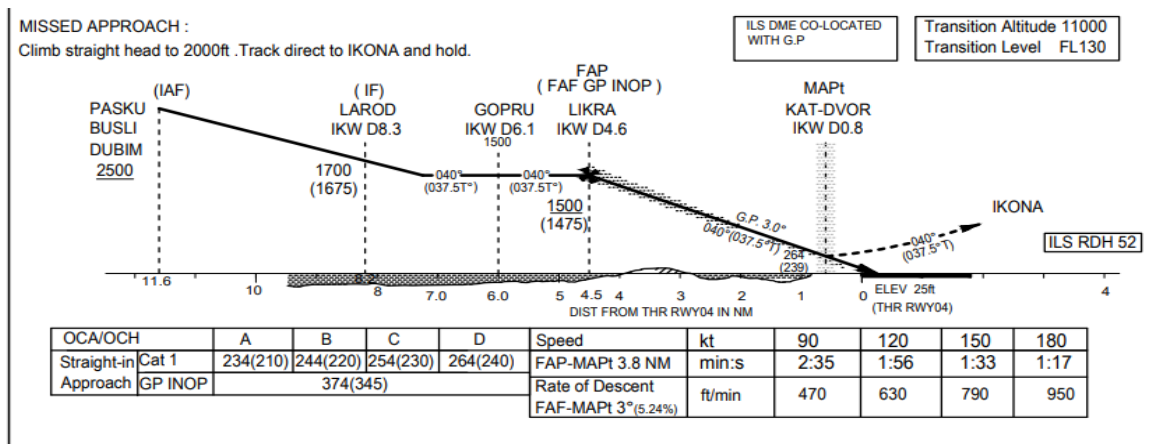
a conditional aspect. The Approach Controller asked whether ALK607 was tracking directly to the position LAROD, which is the intermediate fix for the final approach on ILS RWY04, as indicated in the provided Figure 1. However, the Pilot clarified that they were tracking to the position GOPRU, designed for a 06NM final approach for RWY04. Approach Controller had not positively directed ALK 607 to join a point in the final approach or to rejoin a STAR.

Figure 03 - (Ref AIP Sri Lanka VCBI AD 2-105)
