# **FINAL REPORT**

**AN 12 AIRCRAFT ACCIDENT**

**ON 24.03.2000**

**SKYCABS (PRIVATE) LIMITED ANTONOV - AN12 T BK AIRCRAFT  
BEARING REGISTRATION NUMBER RA11302 ACCIDENT**

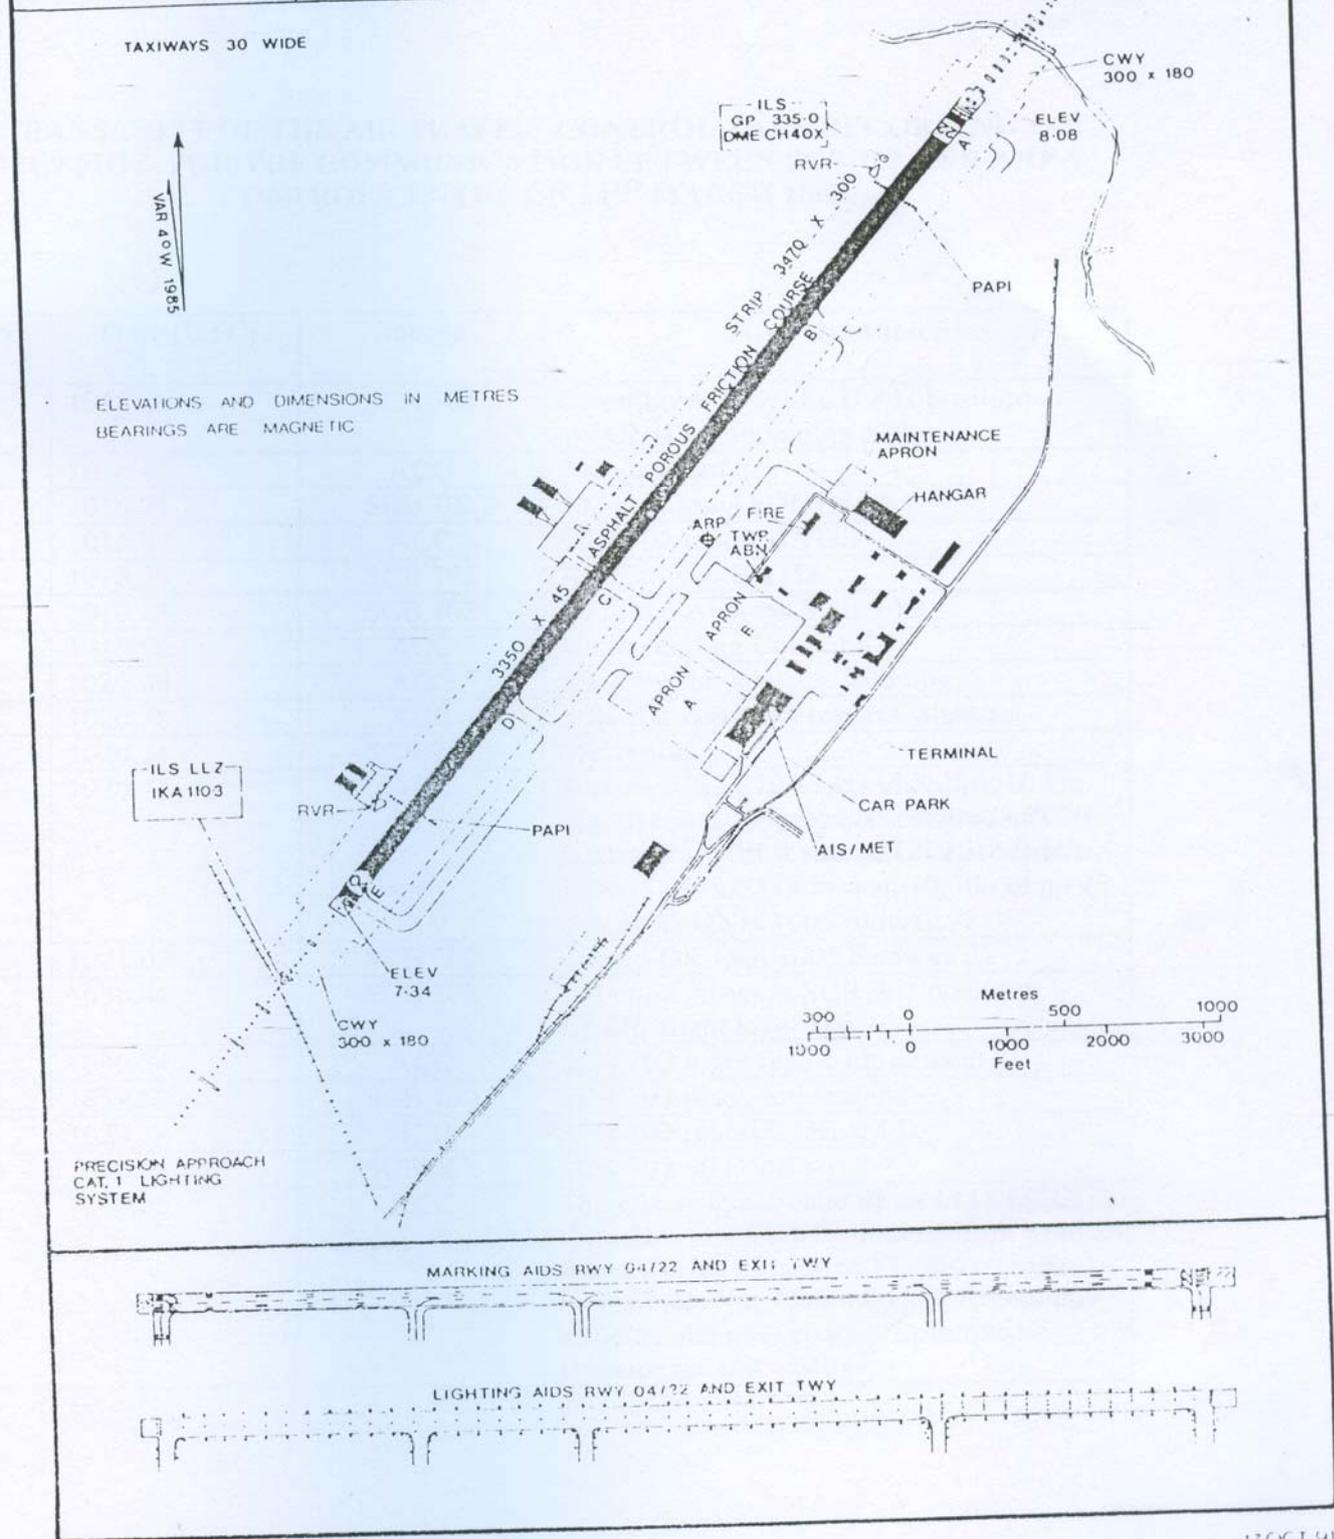
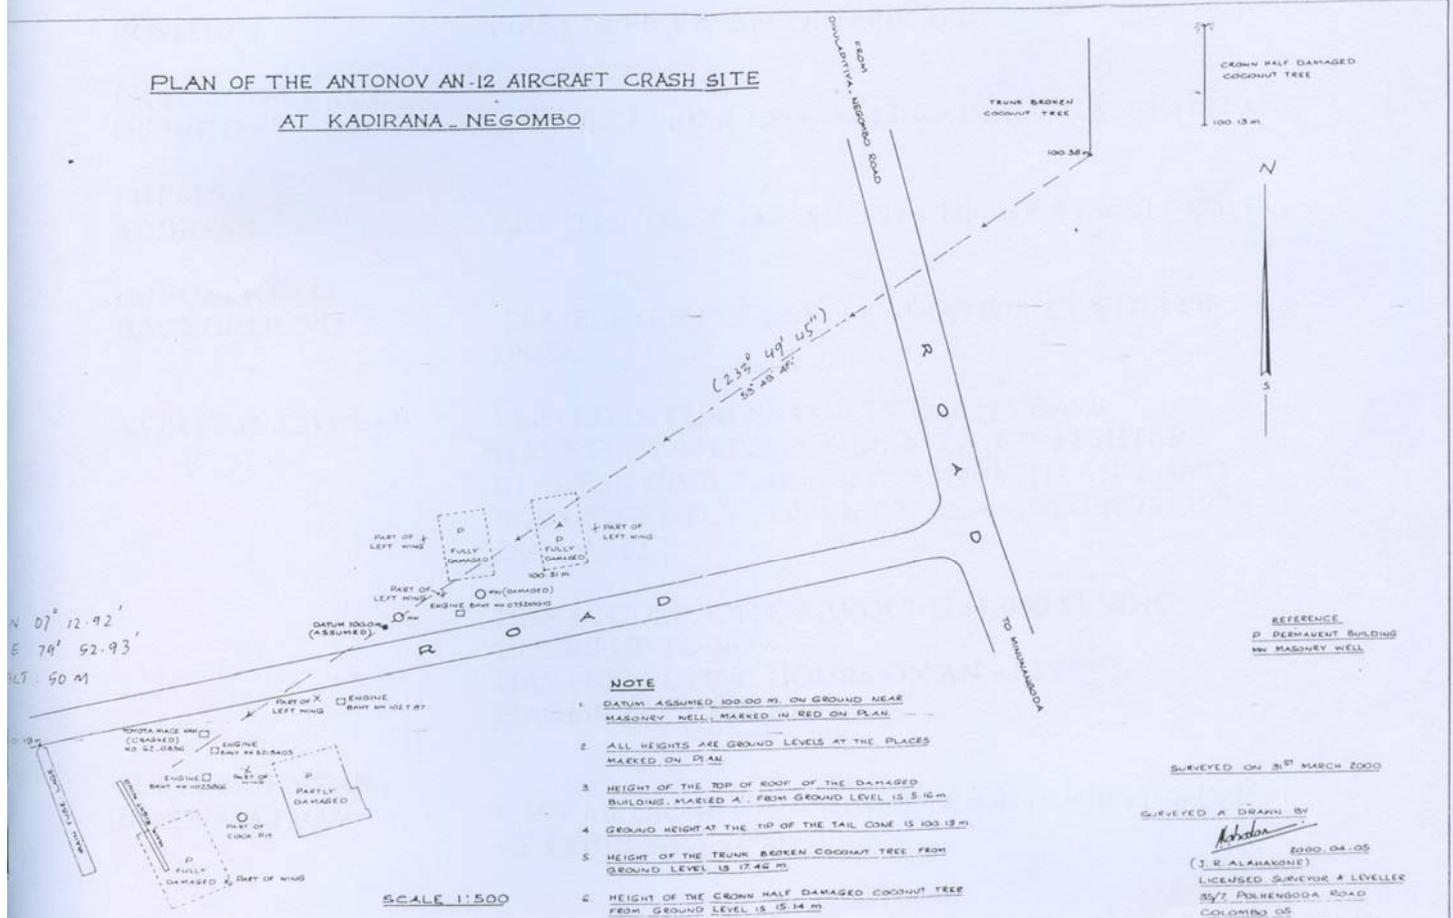
PLAN OF THE ANTONOV AN-12 AIRCRAFT CRASH SITE  
AT KADIRANA, NEGOMBO

After all the four engines stopped, the aircraft entered in to a controlled glide and cut through several coconut trees before crashing on the houses and ground. The left wing had separated first and had broken into several pieces in the process. The right wing too had separated from the main fuselage. All the four engines had got separated and dropped at four places before the main fuselage came to a rest. All four propellers were in the feathered position prior to ground impact.

The cockpit and the front portion of the fuselage had separated from the main section of the aircraft fuselage. The cockpit and its instruments had been further damaged and displaced during the rescue operation to remove the victims from the aircraft as well as those who were buried under the collapsed houses. The Wreckage Distribution Chart is attached as Appendix 4 in Section 5 of this report.
