# **FINAL REPORT**

**INCIDENT OF AERO LANKA FLIGHT RNL 106,  
HS 748 SERIES 2B, REGISTRATION 4R-SER,  
ON 02<sup>ND</sup> DECEMBER 2006  
AT COLOMBO AIRPORT, RATMALANA – SRI LANKA**

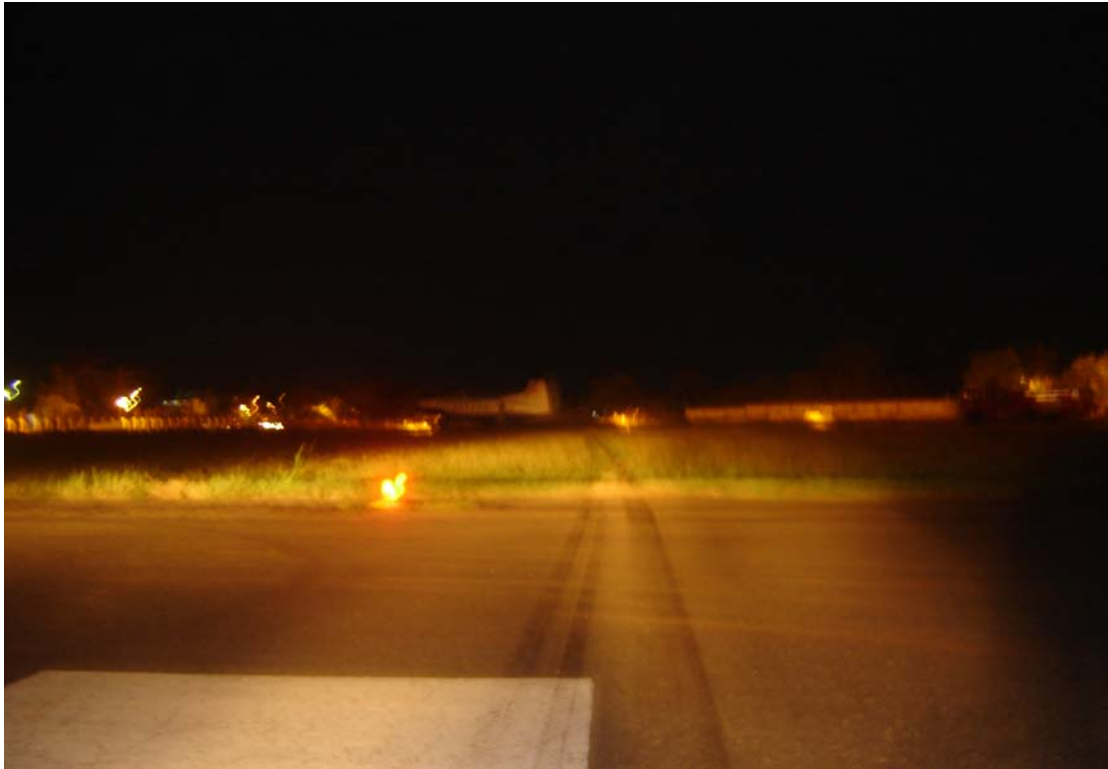
The starboard inner tyre (wheel #3) deflated while decelerating on the runway and the aircraft came to rest on the soft grass of the overrun area of Runway 22 left of the centreline and heading in a southerly direction. There was no apparent damage to the aircraft other than the deflated tyre. The aircraft engines were shutdown normally. There were no injuries to passengers or crew and the passengers disembarked via the aircraft's aft air stairs.

**Night time picture of the aircraft on the stopway after the overrun**

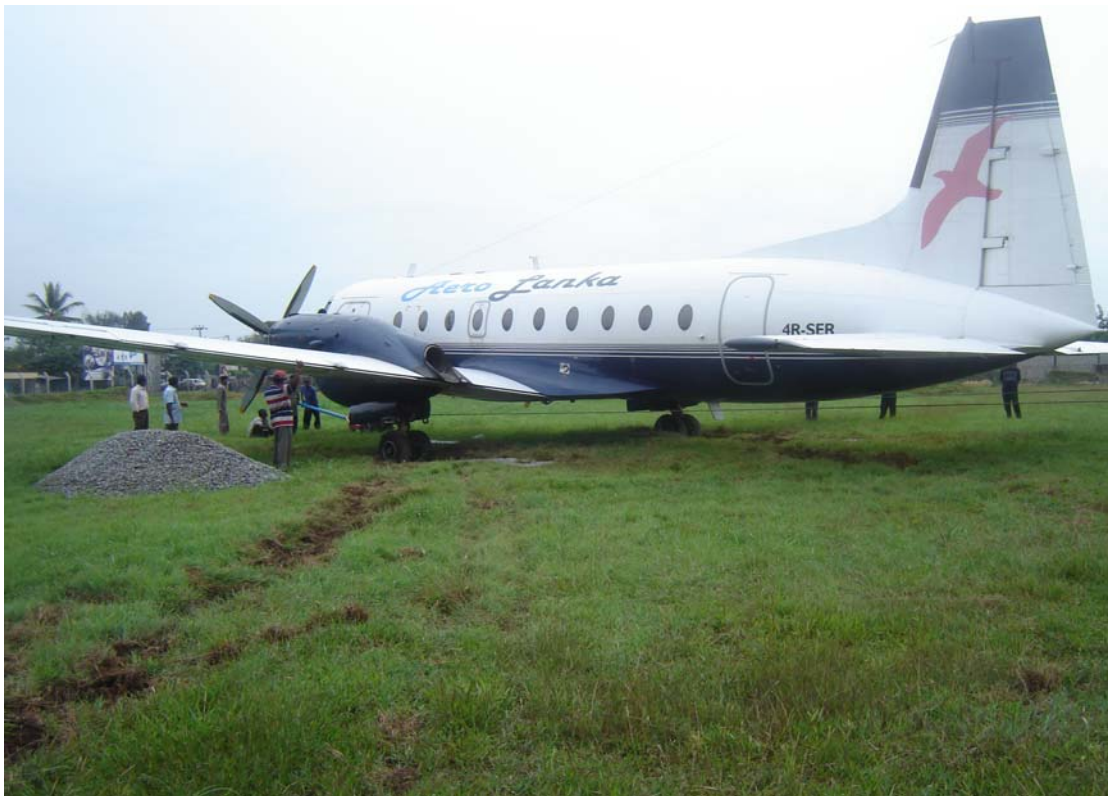
- 2.1. **General:** The flight crew members were properly licensed and rated. The flight crew failed to go through the checklist and make a stabilized approach and subsequently allowed the aircraft to touch down far down the length of runway 22 during the landing. Communication of the flight crew recorded in the CVR confirms that the aircraft approach speed was higher than the normal. This resulted in the aircraft touching down nearly two thirds of the way down the runway. The remaining runway was inadequate to complete the landing roll thus the aircraft overran the runway and came to a rest 213m along the stopway.

**Day time picture of the Aircraft on the Stopway after the overrun**

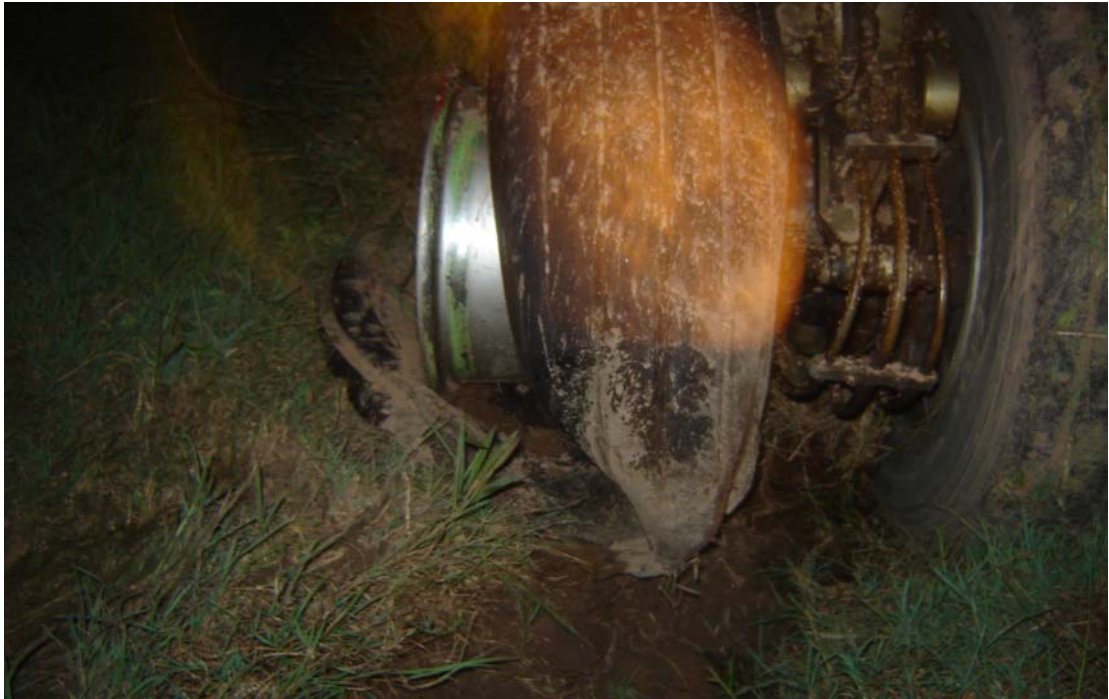
**1.3. Damage to Aircraft:** The starboard inner tyre (Wheel No.3) deflated. In order to trace any other damages invisible, extensive inspections were requested from the aircraft manufacture as per the procedures in aircraft maintenance manual.

**Aircraft right inboard tyre bust**

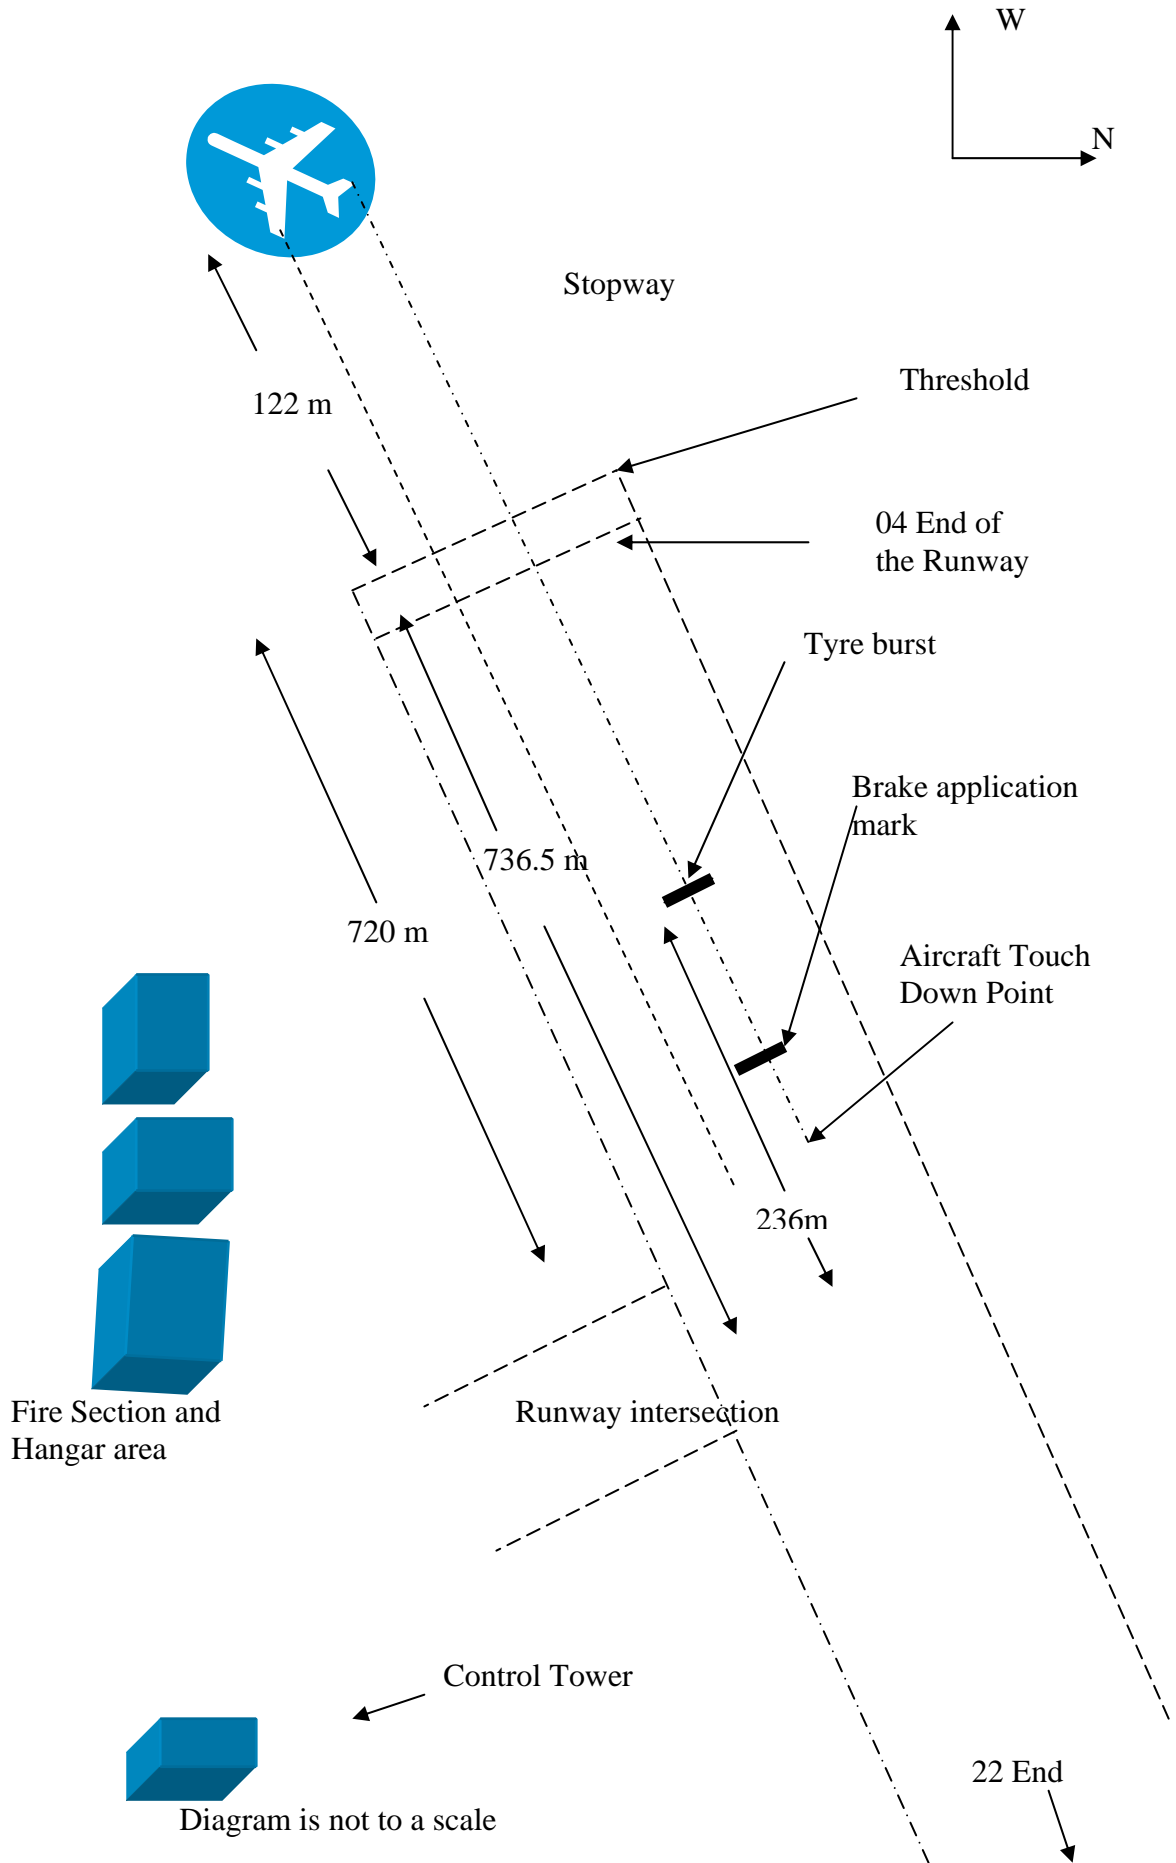
APPENDIX -2- SKETCH OF THE ACCIDENT SITE

- 1.12. **Wreckage and Impact Information:** Tyre markings of landing gear wheels were found on the runway. The first marks of the Main Landing Gear were found on the runway at 668m away from the 04 end. The first mark of the Nose Landing Gear was found 170m beyond those of the Main Landing Gear, which is 498m away from the runway 04 end. The aircraft came to a rest on the stopway overrunning the 04 end by 213m. Tyre trail markings were visible along the runway from near the touchdown point. The aircraft movement on the stopway made deep markings on soft soil.
