# **INTERIM STATEMENT/REPORT**

**Aircraft Accident of Sakurai Aviation Limited, Cessna 172L Skyhawk  
bearing registration mark 4R-GAF crash landed  
at Kimbulapitiya, Negombo, Sri Lanka on 27<sup>th</sup> Dec 2021**

Released by the Civil Aviation Authority of Sri Lanka

Issued on 30<sup>th</sup> Dec 2022

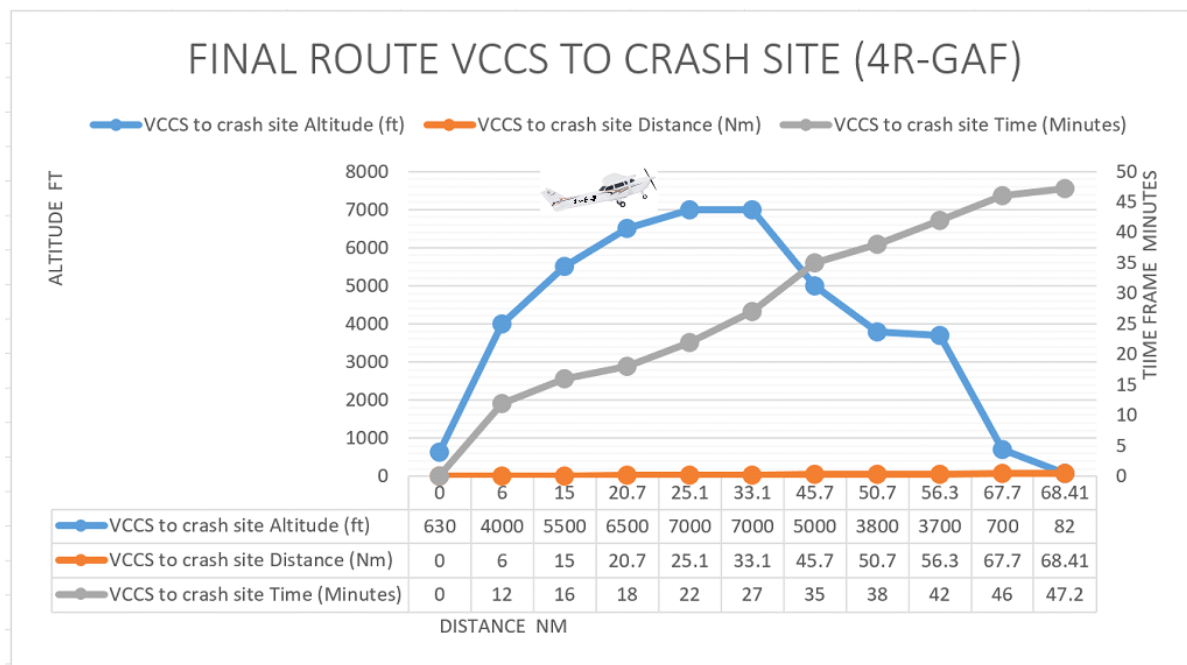
Figure 02: Final route from VCCS to crash site

At approx. 1304 (LT) hrs, 4R-GAF had departed VCCS with total four on board to proceed VCCK. During enroute to VCCK, the PIC had reported a technical problem to the Colombo Approach Control Centre while descending from 5000ft to 3500 ft. Subsequently, he had reported a partial engine failure at approx. 1341hrs (LT). The PIC had informed his intention to land at VCBI or else to carry out an emergency landing at a suitable place. The Controller at Colombo Approach Control Centre had advised the availability of both runways for landing at VCBI. The PIC had accepted runway 22 and informed that MAYDAY will be declared if necessary.

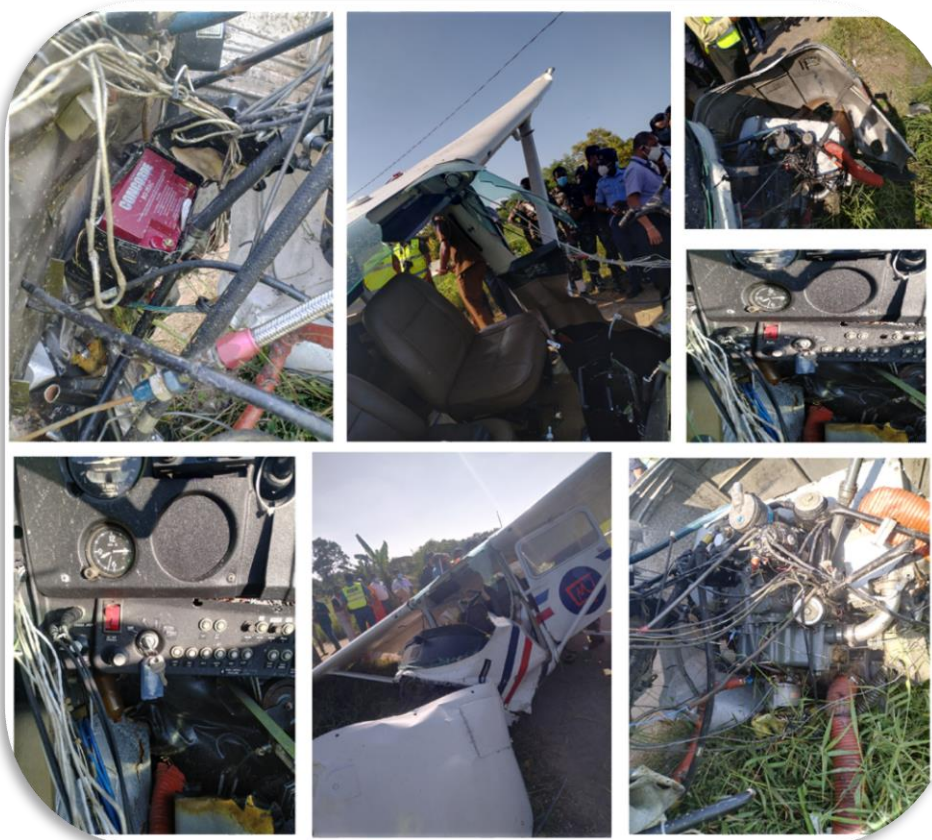
Figure 03: Wreckage of 4R-GAF

The aircraft sustained substantial damages to the RH main landing gear, the landing gear attachment structure and fuselage, propeller, engine mounts and cowlings.

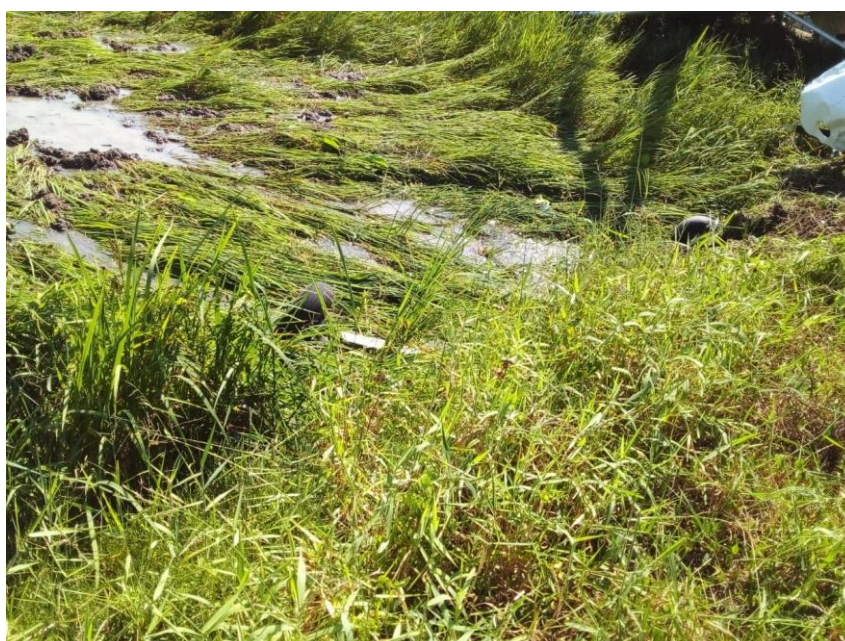
Figure 06: Landing area at Paththeyam Watta, Kimbulapitiya

The aircraft had carried out a crash landing in a paddy field located at Paththeyam Watta, Kimbulapitiya, Negombo located in Gampaha District in Sri Lanka. There were prominent ground marks was visible in the rice paddy.

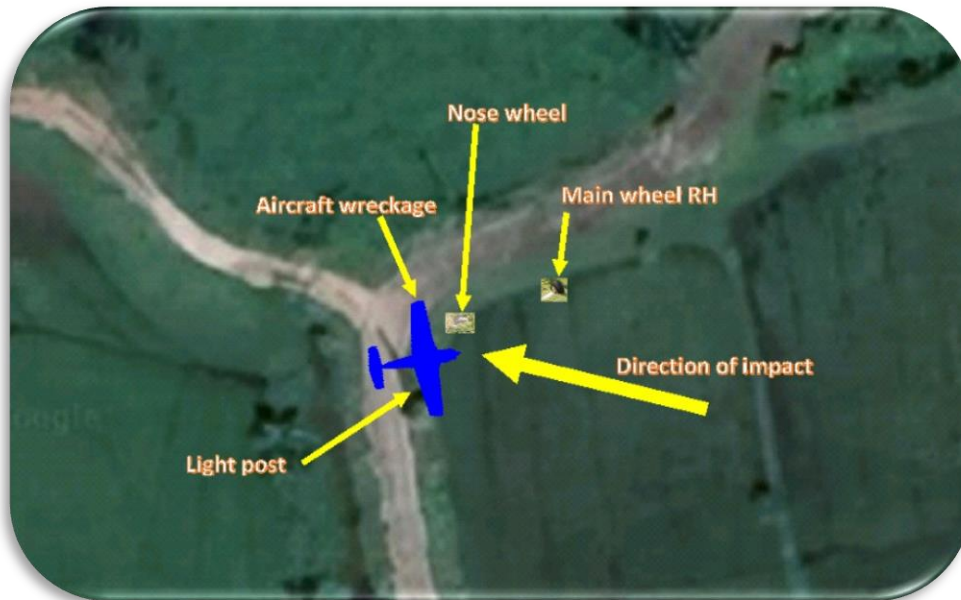
*Figure 07: Landed area Paththeyam Watta at Kimbulapitiya*

The aircraft had crash landed on a paddy field. The nose wheel and right-hand main wheel had been separated and fallen in the crash site at distance from 13m and 38m from the aircraft. A Prominent ground marks were visible after landing in the rice paddy.

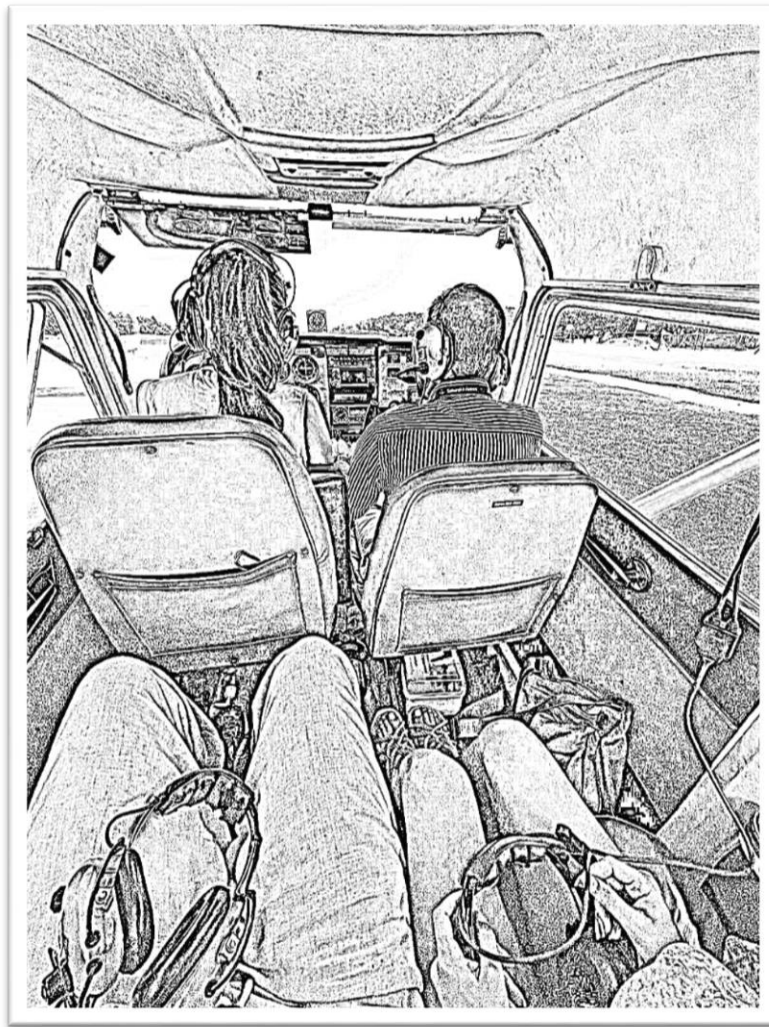
*Figure 09: Seating View*

With respect to the seating arrangements, other occupant was seated in L/H control seat whereas the male passenger was seated behind that seat. The female passenger who was injured was seated behind the R/H control seat which was occupied by the PIC.

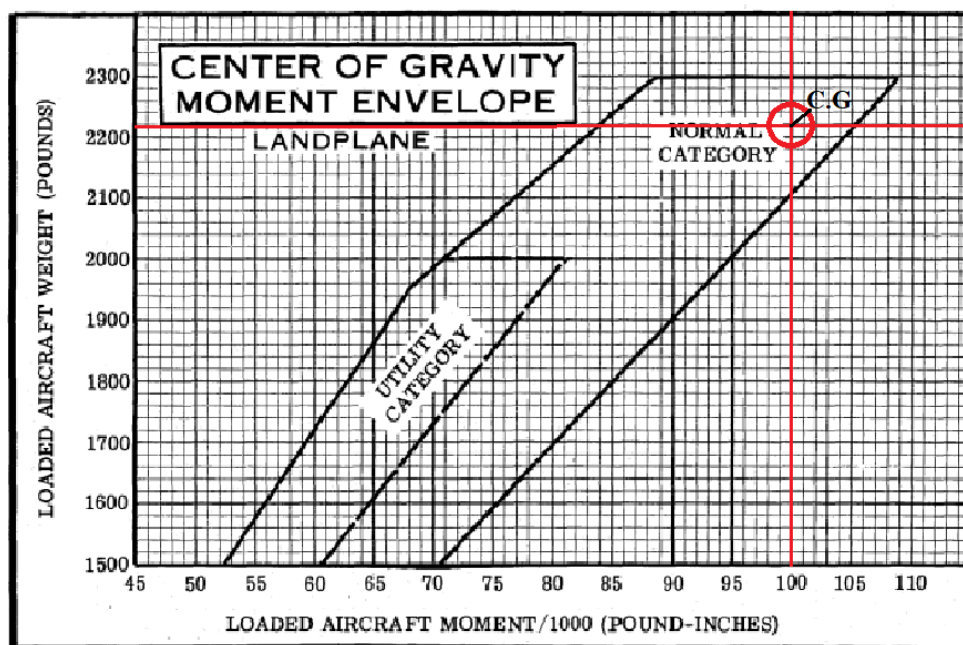
Figure 11: Weight & Balance chart, graph

As per the weight and balance graph, the Centre of Gravity (CG) value is 101 and the loaded moment was remained within the limits of (CG) defined by the Manufacturer.

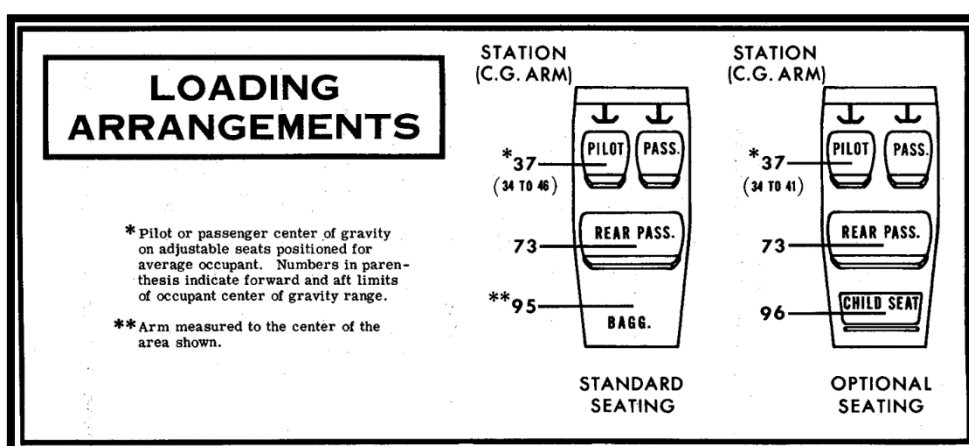
Figure 12: Loading Arrangement given in the Owner's Manual

According to the evidence, the PIC had occupied the right-hand seat and the other occupant had occupied the left-hand seat from the sector commenced from VCCS. Pursuant to the Section on “weigh & Balance” given in the Owner's Manual found on board requires the PIC to be occupied in left-hand seat as the aircraft being a single pilot operated aircraft.

Furthermore, as per the Regulations, the control seats of an aircraft equipped with fully functioning dual controls shall not be occupied in flight except by pilots, who are licenced in respect of the type of aircraft and the class of operations in which the aircraft is flown or who hold such other licences, endorsements and ratings, and are authorized by the DGCA.

- III. The Air Operator shall ensure not to accept any aircraft for a flight in any un-airworthy condition.
- IV. The Air operator shall ensure that Pilots (PIC) to be occupied in left-hand seat in dual control flight in CAT operations.

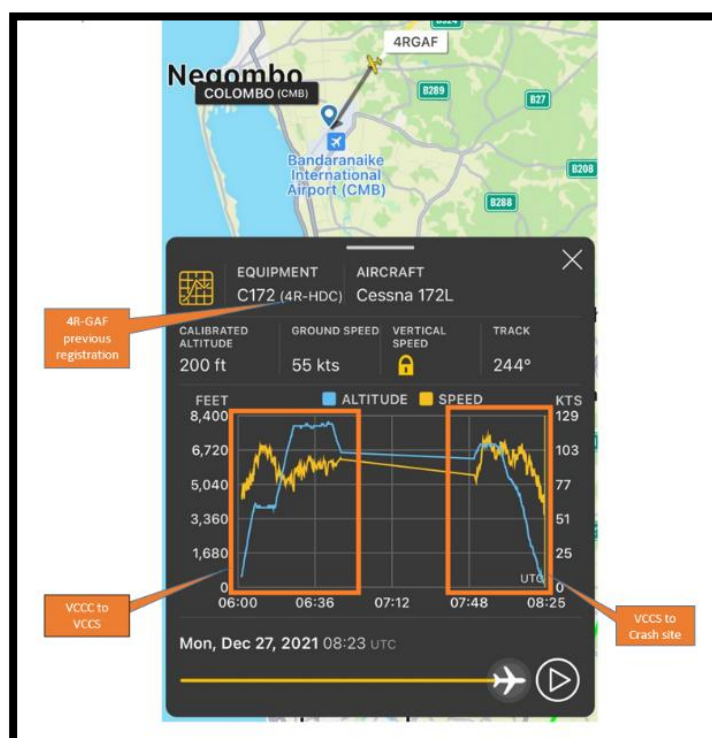
Figure 13: Altitude vs Speed chart (source: Radar 24)

The PIC stated that during descend close to 5000 ft the aircraft engine was getting a bit of rough and then he had observed the engine rough running with the RPM fluctuation while descending further from 5000ft to 3500ft during enroute from VCCS (Approximately 1339hrs, area west of Kurunegala, Sri Lanka - Please refer *Figure 01: Flight Path -source: Radar 24 and Figure 13*).

It was probable that the technical issue of the aircraft had started 35 minutes after take-off from VCCS.

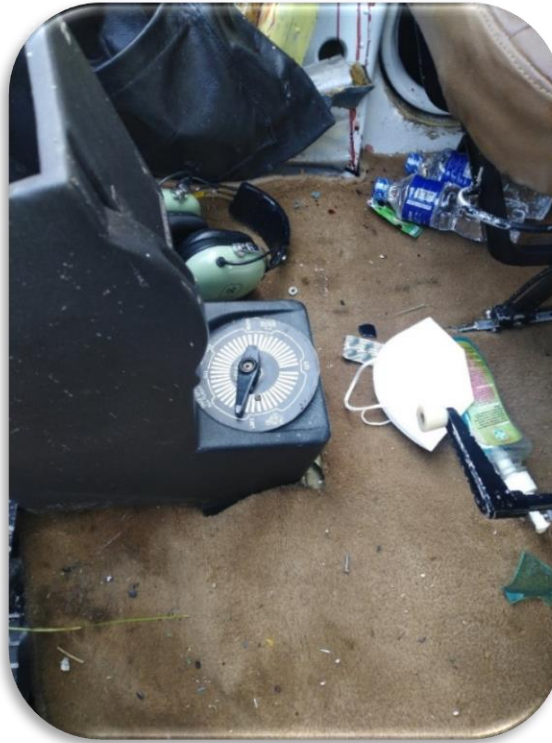
*Figure 14: Fuel selector valve*

According to the PIC, he had placed the fuel selector valve to the "BOTH ON" position when departing VCCS and it was remained in that position until the accident. When the CAASL team arrived to the crash site, the fuel selector valve had been set to the "LEFT" position. The fuel selector valve in the aircraft is shown in Figure below.
