III වැනි සැසි වාර්තාව - 1979  
SESSIONAL PAPER No. III - 1979

Report of the Commission of Inquiry  
appointed by His Excellency the President  
to inquire into the causes and circumstances in which  
Lofleider Icelandic Airways Aircraft DC-8-63F TF-FLA  
met with an accident in the vicinity of the Katunayake Airport  
on 15th November, 1978

REPORT OF THE COMMISSION OF INQUIRY APPOINTED BY  
HIS EXCELLENCY THE PRESIDENT TO INQUIRE INTO THE CAUSES  
AND CIRCUMSTANCES IN WHICH LOFTLEIDER ICELANDIC  
AIRWAYS AIRCRAFT DC-8-63F TF-FLA MET WITH AN ACCIDENT  
IN THE VICINITY OF THE KATUNAYAKE AIRPORT ON  
15TH NOVEMBER, 1978

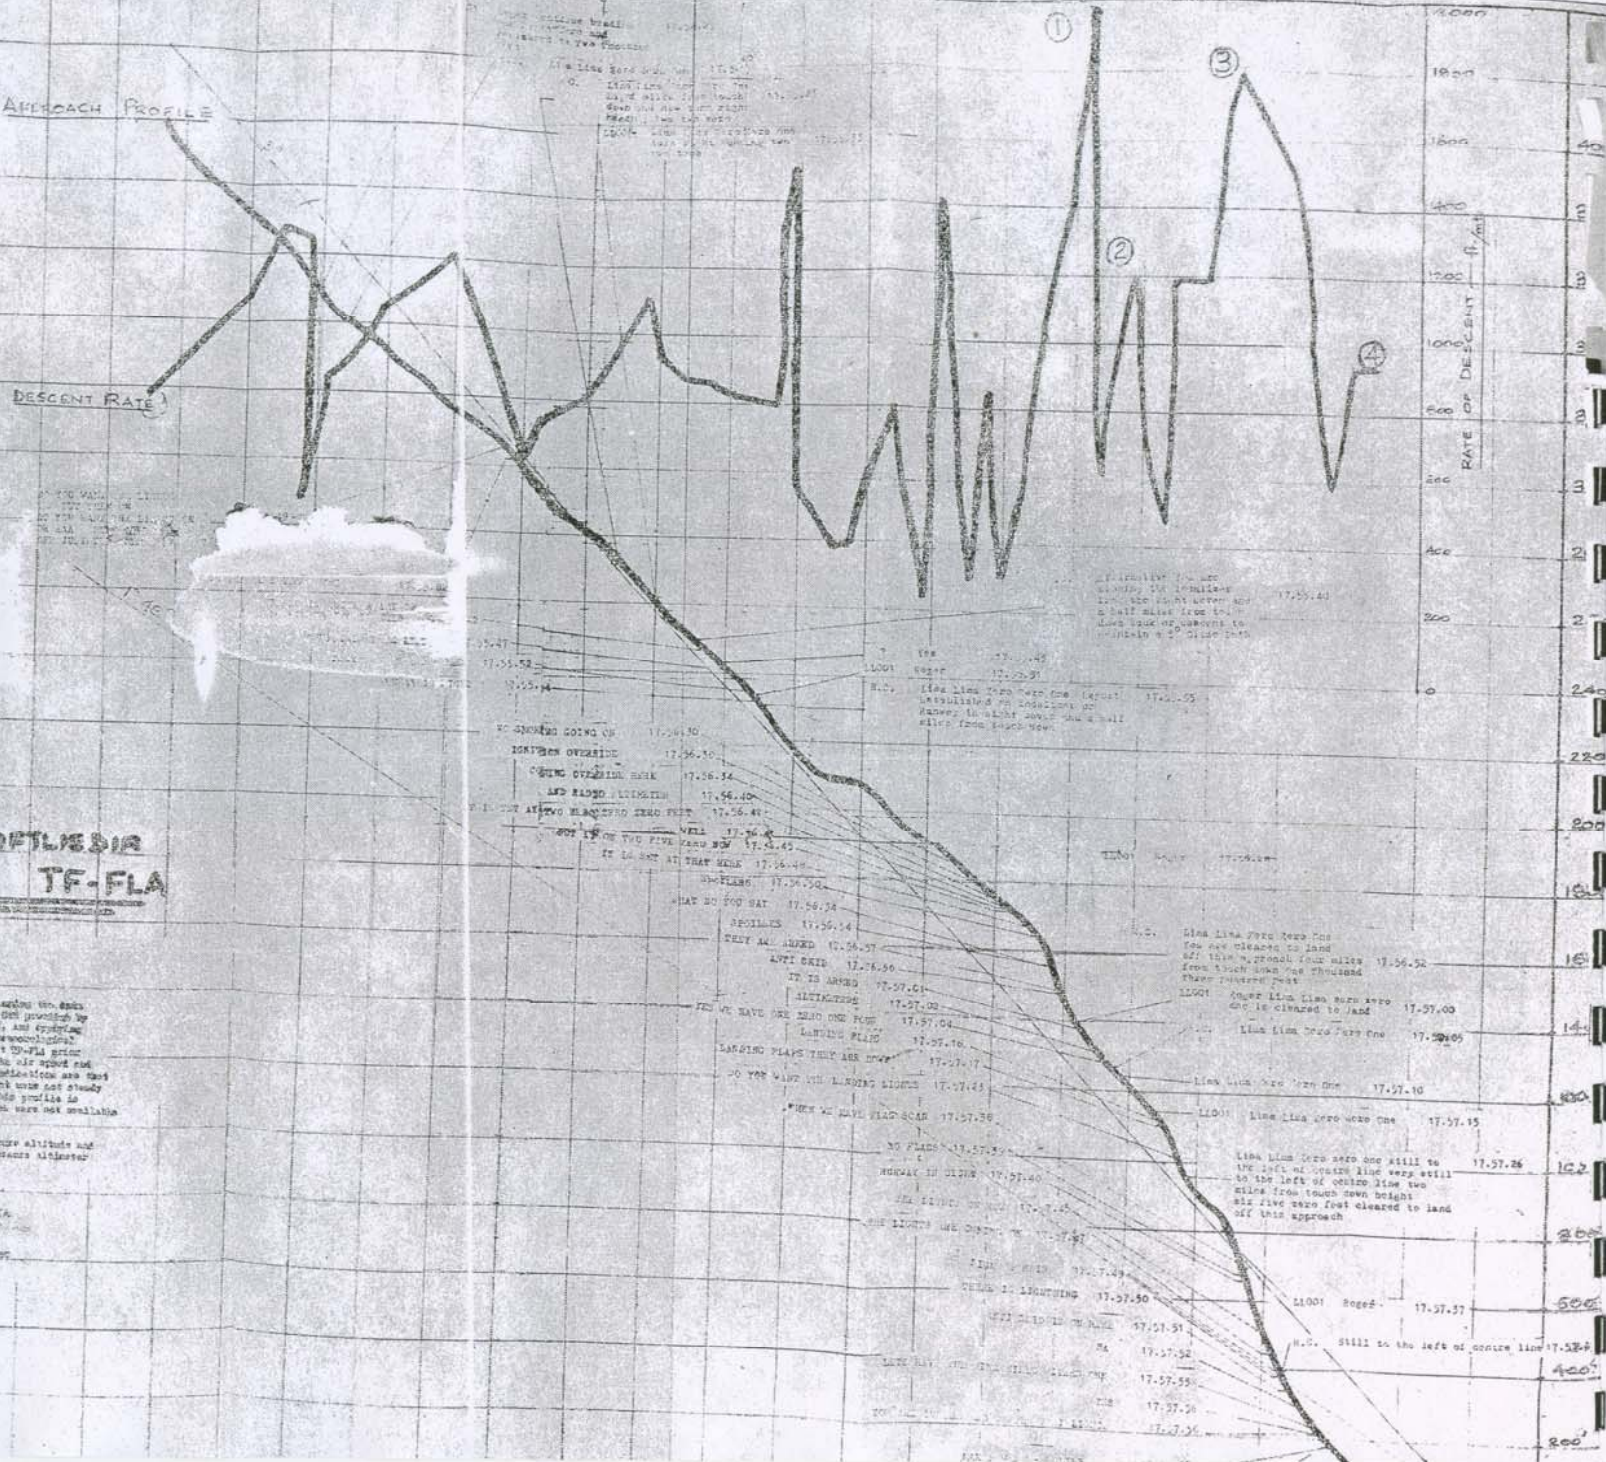
2. The altitude used in this profile is the pressure altitude and the accuracy falls within the tolerance of pressure altimeter used in within the region of  $\pm 50$  feet.
