FINAL REPORT

SRI LANKAN AIRLINES AIRBUS A330-300, 4R-ALQ COCKPIT & CABIN SMOKE INCIDENT DURING CLIMB FROM MEL TO CMB AT FL 220, 60NM NORTH-WEST OF MEL AIRPORT ON 12TH FEB 2024

Released by the Civil Aviation Authority of Sri Lanka

Issued on: 18/09/2024

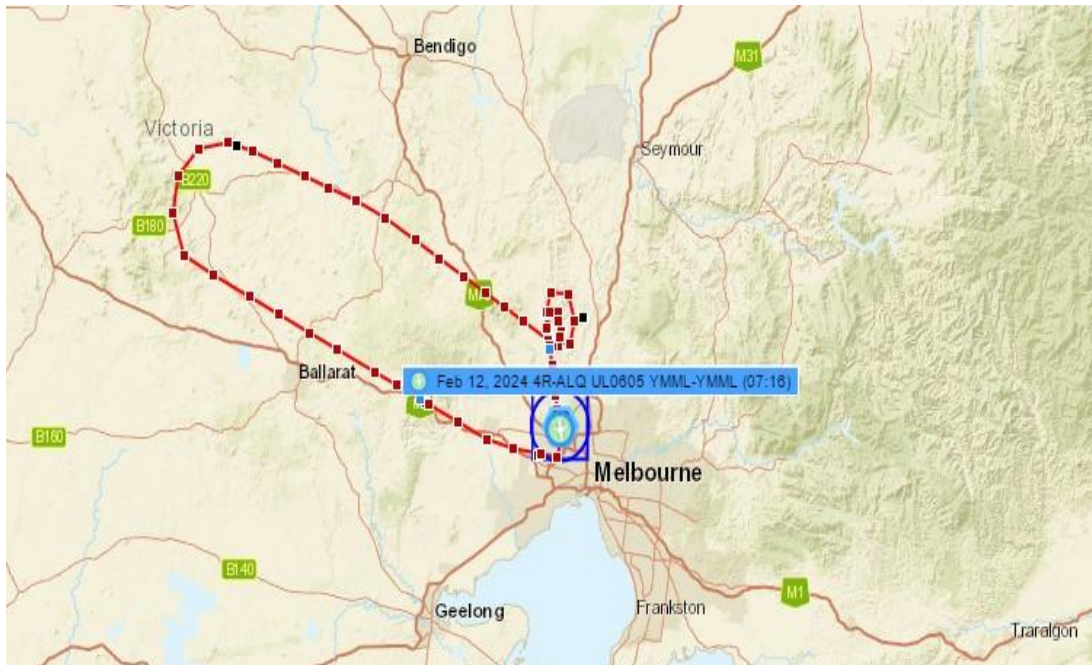
Figure 01: Aircraft path during and after landing

Since the take-off weight was 223t at MEL and when it was turning back again to MEL it was 218t. The maximum landing weight of the aircraft was 187t. Hence, the aircraft was prepared for an overweight and unscheduled landing after all the checklists were completed and briefed. The aircraft was approached and landed safely at Melbourne International Airport without an incident at 08.23 UTC. Touchdown was at 400ft/min with no auto breaks. The aircraft was vacated via taxiway J and taxied to gate D4 safely at 08.30 UTC.
