FINAL REPORT

**SriLankan Airlines Flight UL 226,
Airbus Industries A330-200, bearing registration 4R-ALS,
experienced a lateral runway excursion during
landing at Bandaranaike International Airport, Katunayake,
Sri Lanka on 08th July 2024**

Released by the Civil Aviation Authority of Sri Lanka

Issued on: 5th Feb 2025

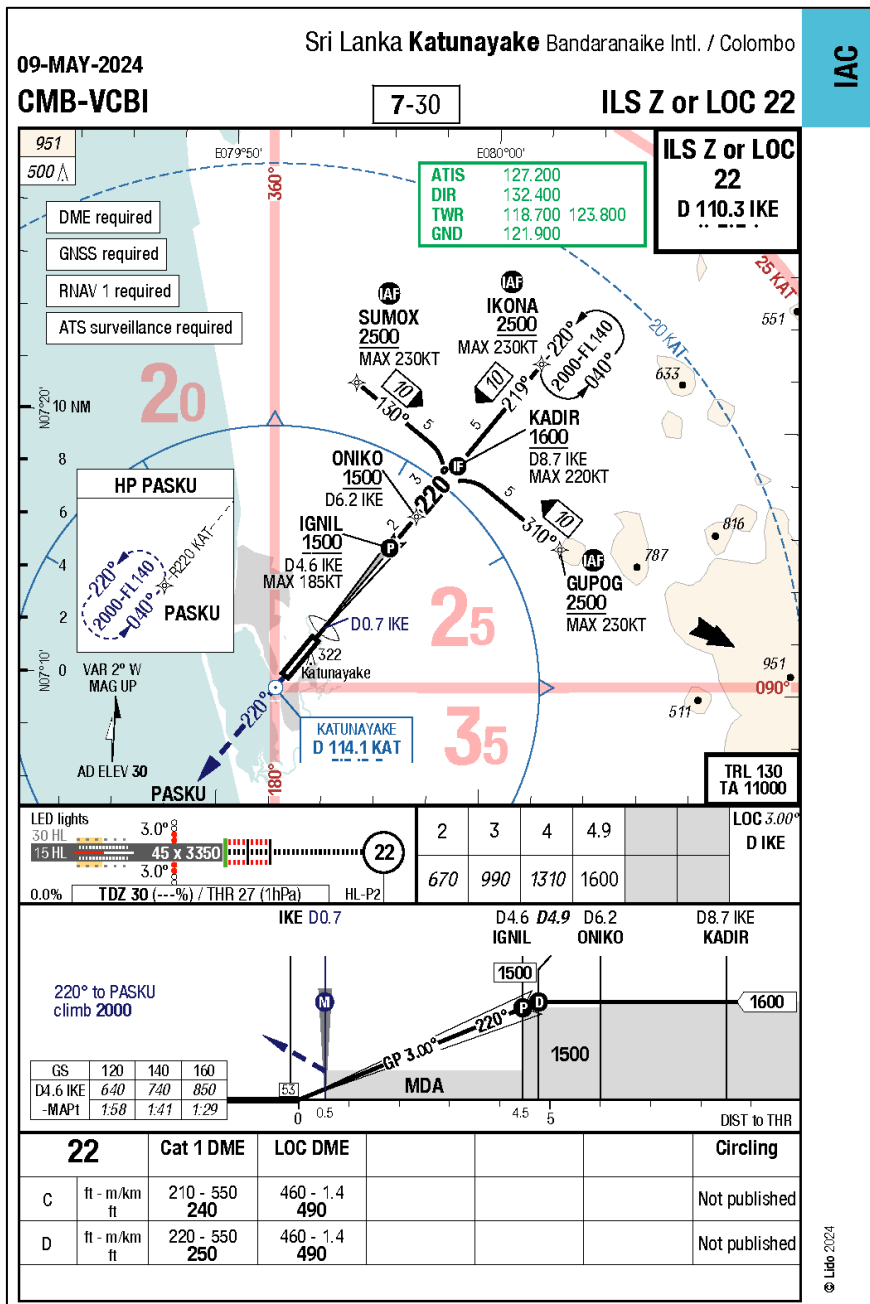
Figure 10– VCBI ILS Approach Chart for Runway 22

Runway 22 at VCBI is equipped with a standard ILS, DVOR/DME and PAPI system and also runway and approach, lighting system.

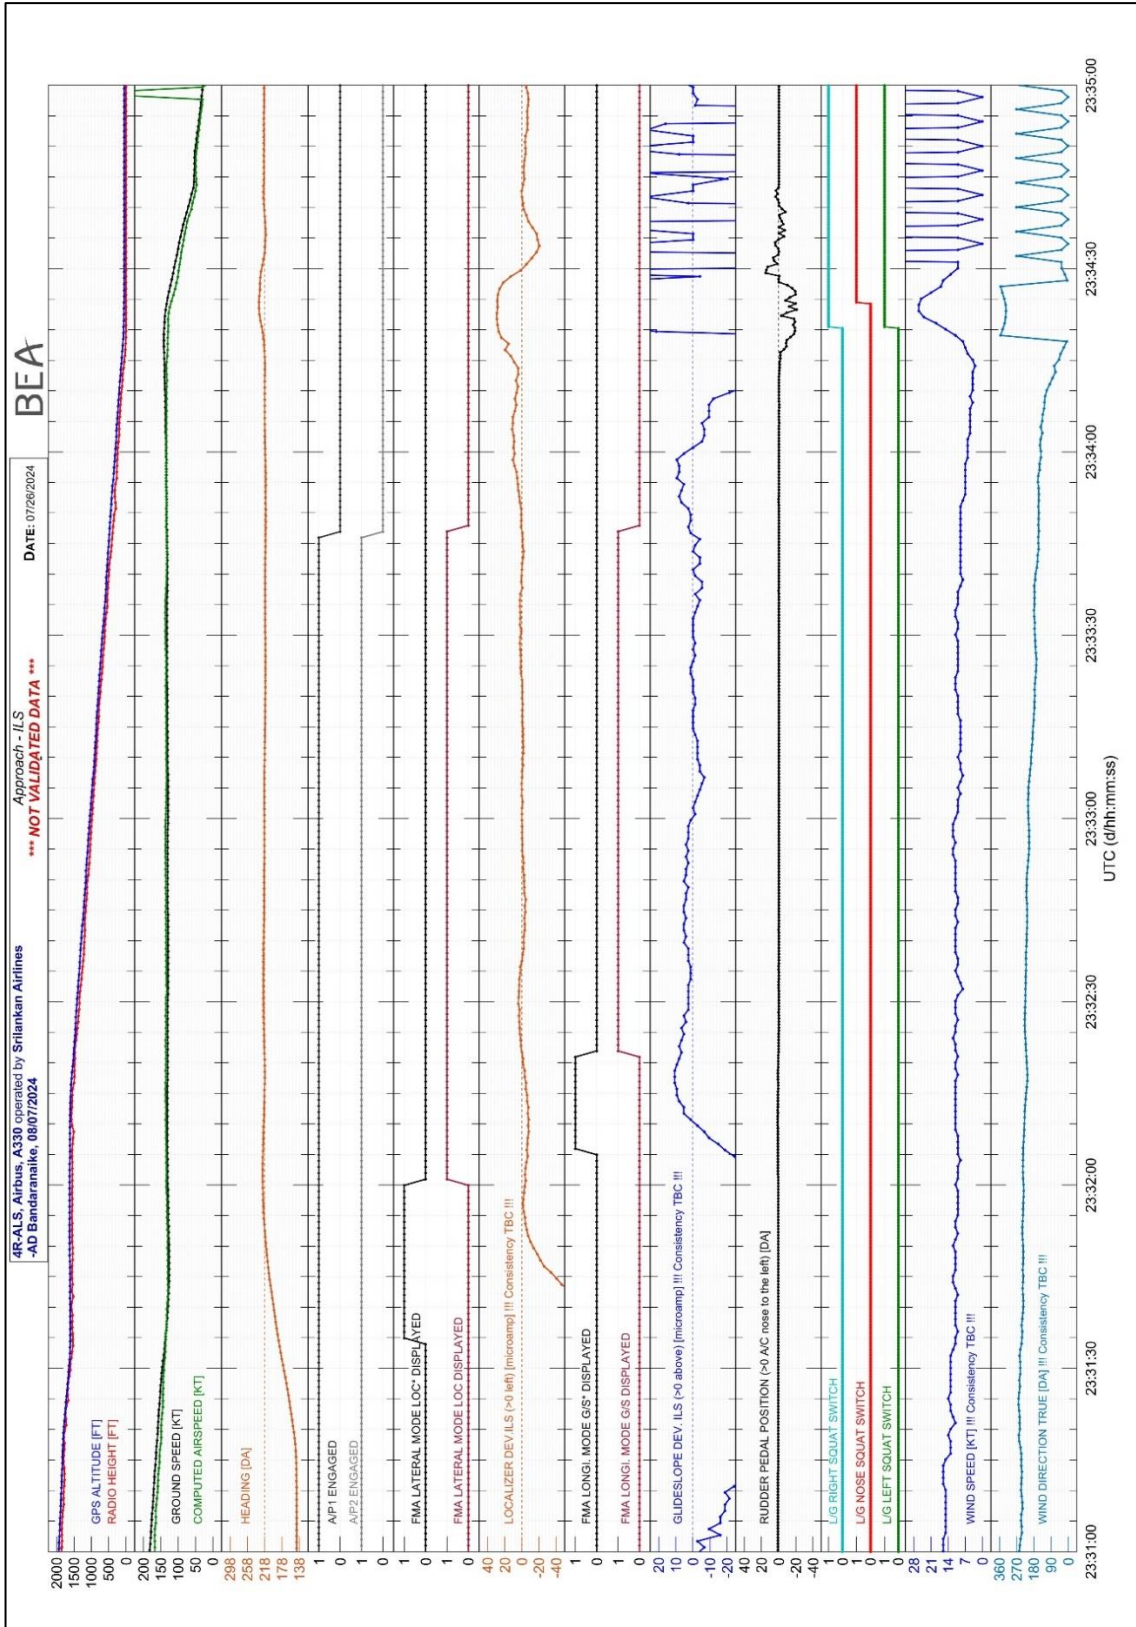
FDR Data analysis – 4R-ALS Final approach

During this period there was no any call out from the PM (‘Localiser’ or ‘centreline’ or ‘deviating left’) to remind the PF to align the aircraft with the extended runway centreline. According to PM, he knew the aircraft was not aligned with runway centreline, but he observed that PF had applied flight inputs to correct the mis-alignment and therefore, he did not intervene with controls. According to PF, to counter the left deviation, he applied a rightward rudder inputs instead roll inputs as the aircraft was close to the ground.
